**Subject: Cursory Geotechnical Evaluation Report
Skagit County Jail – Alf Christianson Site**
Skagit County Tax Parcel Numbers: P121047, P26886, P26788, P53373, P53374, P53375,
P53376, P53377, P53378, P53379, P54112, P54113, P54114, P54115, P54116, P54117,
P54118, P54119, P54120, P54122, and P103224
Mt. Vernon, WA 98273

MTC Project Number: 13B093-01

**Cursory Geotechnical Evaluation Report
Skagit County Jail – Alf Christianson Site**

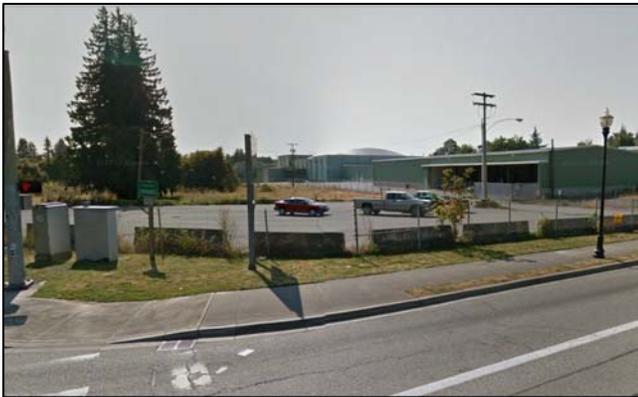
Figure 3. Typical Surface Conditions, North Half of Prospective Site (Google Image)

Much of the property is currently developed with existing improvements including buildings, asphalt paving, and other associated improvements. Some of the smaller eastern parcels historically utilized as single-family residential parcels are presently undeveloped and vegetated with field grass, sparse brush, and trees.

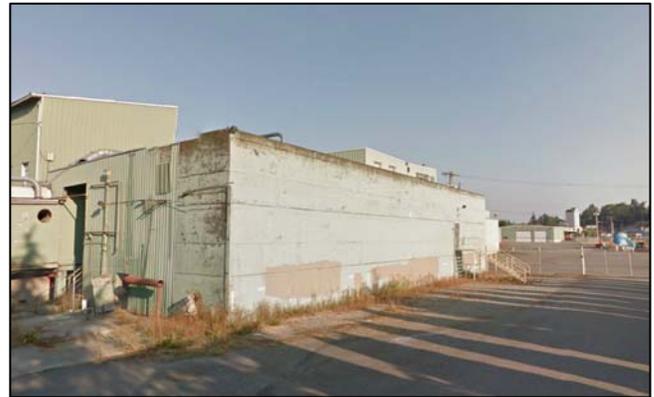
Figure 4. One of the Existing Structures, South End of Prospective Site (Google Image)

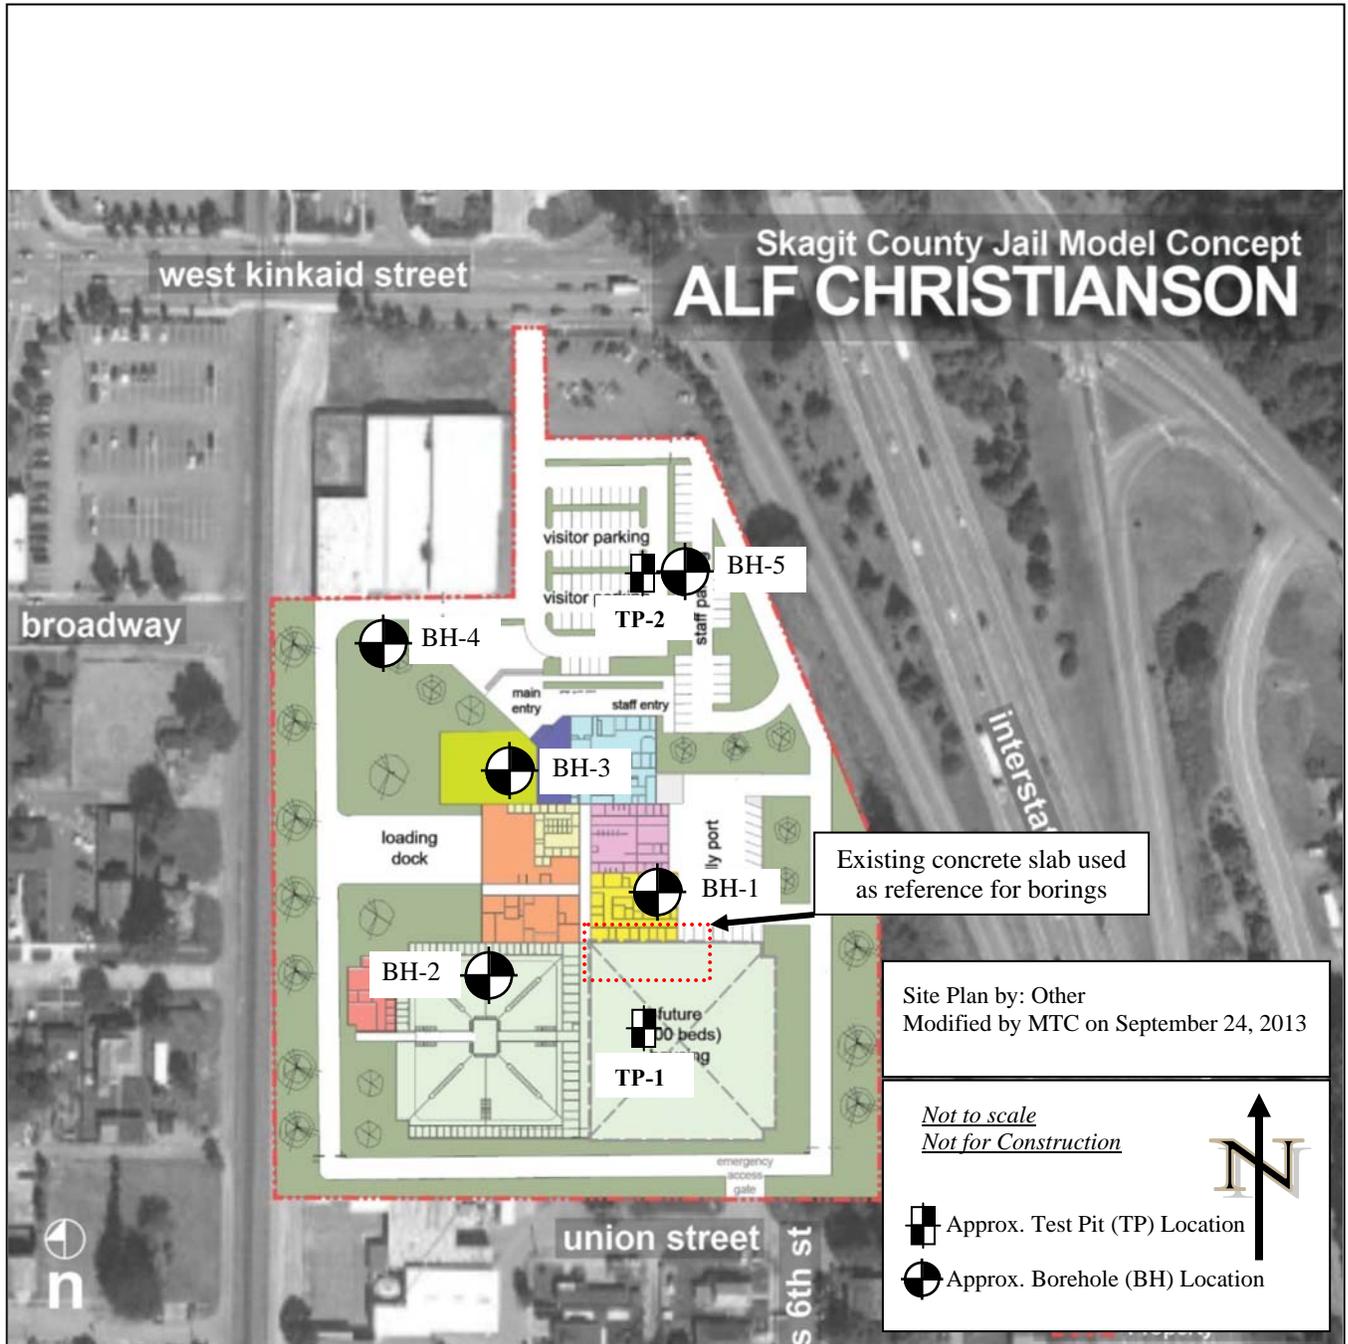
Site Map
 Skagit County Jail–Alf Christianson
 Mt Vernon, Washington

Exploration locations are shown on the attached site plan included in Appendix A, Figure 6. Additional information on the site exploration program is provided with our Exploration Logs included in Appendix B of this report.

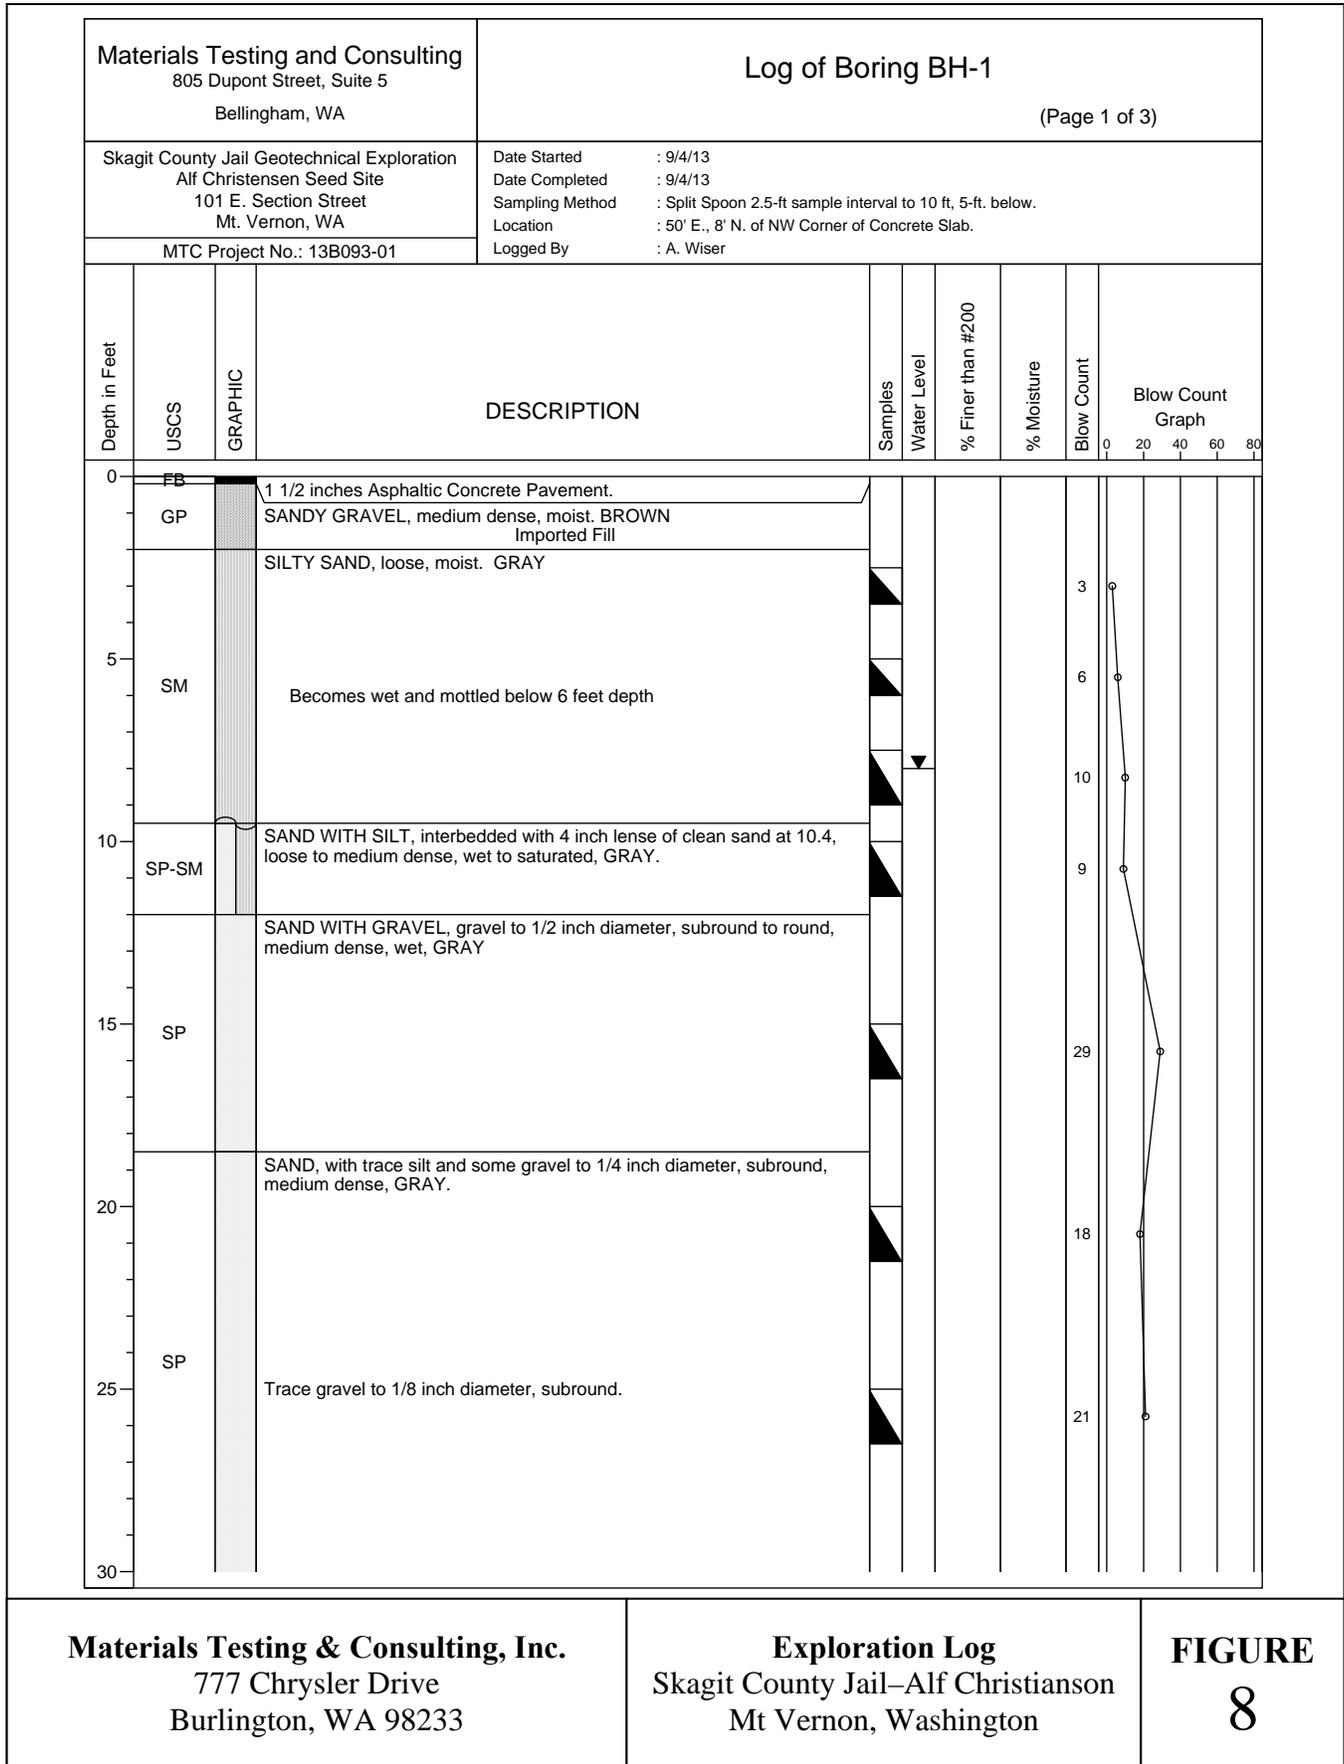
Exploration Log
 Skagit County Jail–Alf Christianson
 Mt Vernon, Washington

Materials Testing and Consulting 805 Dupont Street, Suite 5 Bellingham, WA		Log of Boring BH-1 (Page 2 of 3)							
Skagit County Jail Geotechnical Exploration Alf Christensen Seed Site 101 E. Section Street Mt. Vernon, WA MTC Project No.: 13B093-01		Date Started : 9/4/13	Date Completed : 9/4/13	Sampling Method : Split Spoon 2.5-ft sample interval to 10 ft, 5-ft. below.	Location : 50' E., 8' N. of NW Corner of Concrete Slab.	Logged By : A. Wiser			
Depth in Feet	USCS	GRAPHIC	DESCRIPTION	Samples	Water Level	% Finer than #200	% Moisture	Blow Count	Blow Count Graph
30	SP CL-ML		SILTY CLAY, with some organics (bedded grass and foliage) to 5 percent by volume, soft, wet. Upper inch of fine soil consists of decayed wood (Peat). GRAY.					4	
	SP		SAND WITH GRAVEL, coarse grained with subround gravel to 1/4 inch diameter, loose, wet. GRAY						
35	PT SM-OL		Interbedded alluvium consisting of silty sand, sand and sand with gravel with fine grained clay and silt with organics and lenses of peat. PEAT, consisting of leaves and grasses displaying minor decay, soft, wet. RED-BROWN.					7

SM		SILT WITH SAND TO SILTY SAND, with organics, very loose or soft, saturated, GRAY-BROWN. SILTY SAND, no organics present, loose to medium dense, saturated, GRAY.						
40	SM		No Recovery. Based on drilling behavior assumed continuing interbedded alluvium deposits consisting of silty sand, sand and sand with gravel with fine grained clay and silt with organics and lenses of peat					13	
45	CL-ML		SILTY CLAY, with organics consisting of bedded grasses and foliage, soft, wet. GRAY.					6	
	SM		SILTY SAND, fine grained sand, interbedded with 1 inch thick lenses of silt with organics, loose or soft, GRAY.						
50	SP-SM		SAND WITH SILT, medium dense, saturated, GRAY. Poor sample recovery, sample completed saturated and soupy sand with silt.					20	
55	SP		SAND, fine to medium grained sand, medium dense to dense, saturated. GRAY.					31	
60			Increased silt content, becomes sand to sand with silt, medium dense.

Materials Testing and Consulting 805 Dupont Street, Suite 5 Bellingham, WA		Log of Boring BH-1 (Page 3 of 3)							
Skagit County Jail Geotechnical Exploration Alf Christensen Seed Site 101 E. Section Street Mt. Vernon, WA		Date Started : 9/4/13 Date Completed : 9/4/13 Sampling Method : Split Spoon 2.5-ft sample interval to 10 ft, 5-ft. below. Location : 50' E., 8' N. of NW Corner of Concrete Slab. Logged By : A. Wisner							
MTC Project No.: 13B093-01									
Depth in Feet	USCS	GRAPHIC	DESCRIPTION	Samples	Water Level	% Finer than #200	% Moisture	Blow Count	Blow Count Graph
60								23	
65	SP		Decreased silt content. SAND.					22	
70			Thin, 1 to 2 inch thick, interbedded lense of dark brown silty sand at top of sampler.					13	
75			SAND, with some 1/2 inch diameter, subround to round gravel to 5 percent by volume, medium dense to dense, saturated. GRAY.					36	
80								28	
85	GP		GRAVEL WITH SAND, medium dense, wet, GRAY.					24

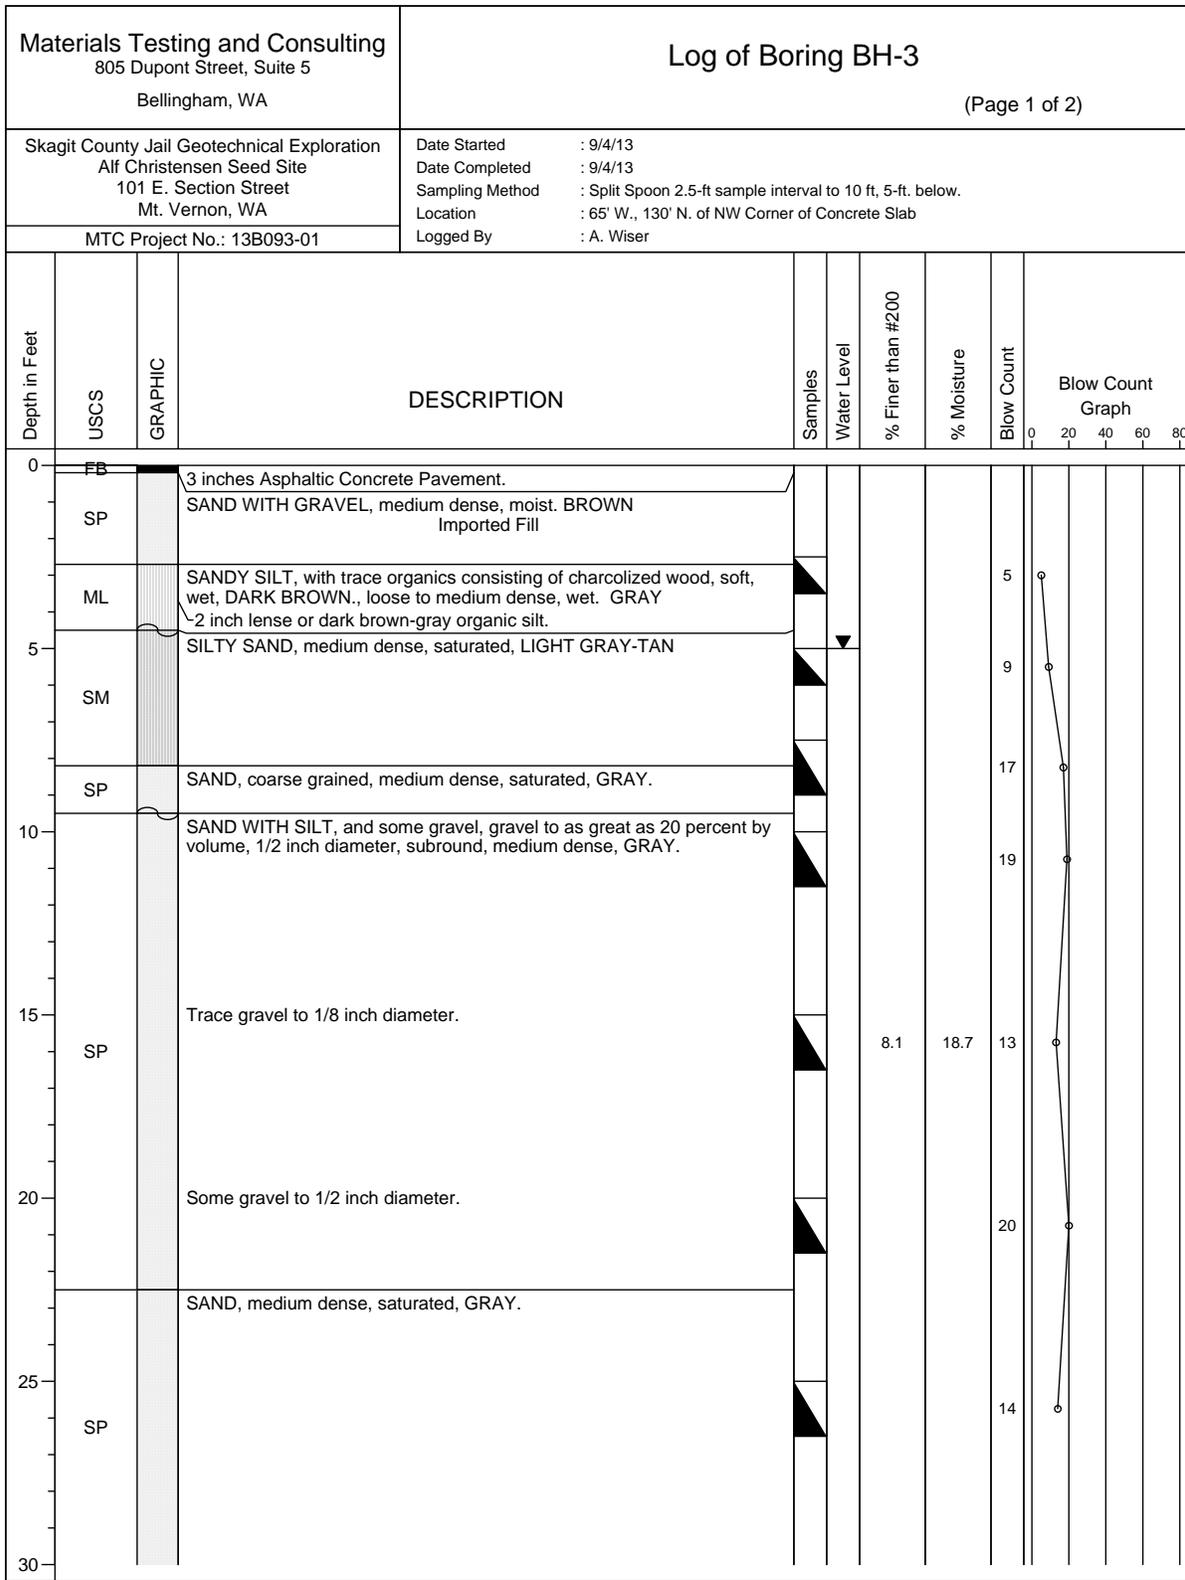
FIGURE
12

Exploration Log
 Skagit County Jail–Alf Christianson
 Mt Vernon, Washington

Materials Testing and Consulting 805 Dupont Street, Suite 5 Bellingham, WA		Log of Boring BH-3 (Page 2 of 2)							
Skagit County Jail Geotechnical Exploration Alf Christensen Seed Site 101 E. Section Street Mt. Vernon, WA		Date Started : 9/4/13	Date Completed : 9/4/13	Sampling Method : Split Spoon 2.5-ft sample interval to 10 ft, 5-ft. below.	Location : 65' W., 130' N. of NW Corner of Concrete Slab	Logged By : A. Wisner			
MTC Project No.: 13B093-01									
Depth in Feet	USCS	GRAPHIC	DESCRIPTION	Samples	Water Level	% Finer than #200	% Moisture	Blow Count	Blow Count Graph
30	SP		SILT, with clay and some organics, very soft, wet, GRAY. Underlain by 2 inch lense of peat.					3	
	ML		SILTY SAND, loose, saturated, GRAY. Inferred interbedded silty sand to sand with silt, silt with organics and peat.					7	
35			Dark brown lense of Peat, .1 inch thick Thin lense of Silt, with some clay, 2 inches thick.					15

SM		Becomes medium dense			46.3	30.8	6	
40			Silty Sand/Peat contact inferred.					17	
45	PT		PEAT, bedded leaves, foliage and wood fragments, soft, wet, DARK BROWN.			60.4	22.5		
	ML		SANDY SILT to SILTY SAND, loose, saturated, GRAY Thin lense of sandy silt to 3 inches thick at 46.0 feet.						
50			Becomes medium dense.						
55									
60			TD 51.5' Boring terminated on medium dense granular soils. Free water encountered at approximately 5.0 to 6.0 feet depth.

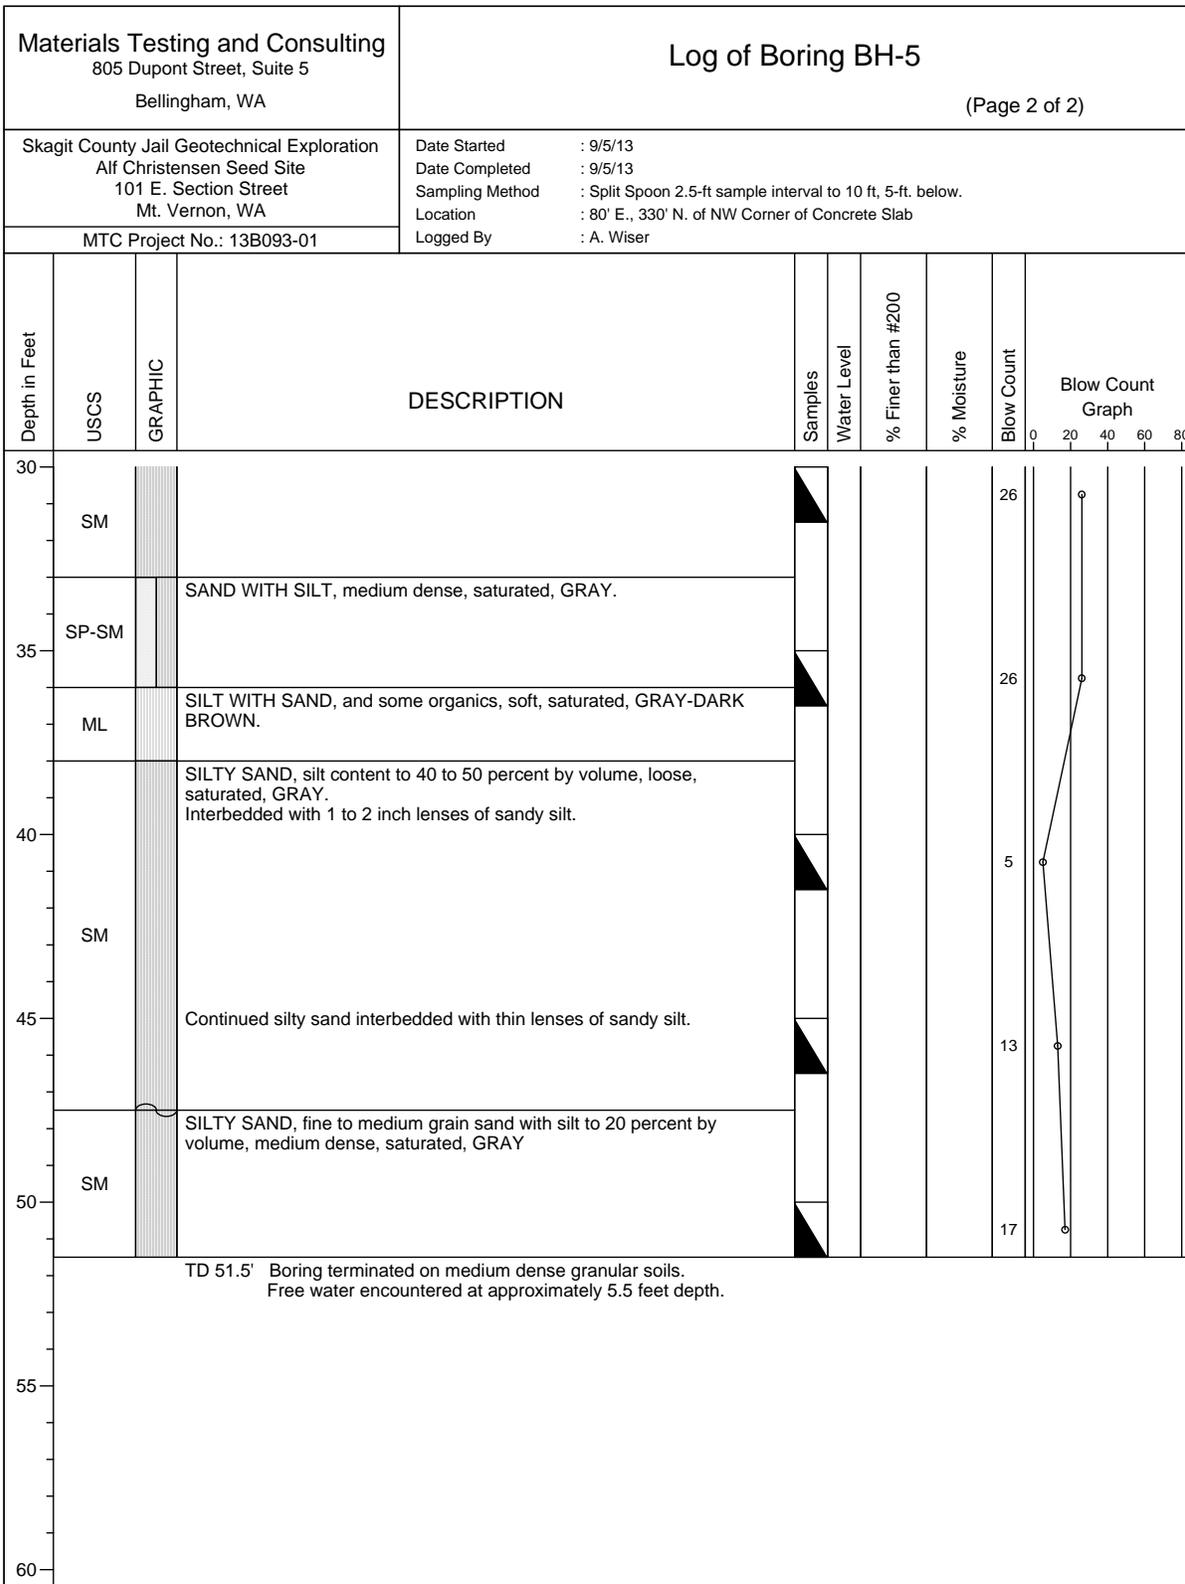
Materials Testing & Consulting, Inc. 777 Chrysler Drive Burlington, WA 98233	Exploration Log Skagit County Jail–Alf Christianson Mt Vernon, Washington	FIGURE 18
---	--	----------------------------

Materials Testing and Consulting 805 Dupont Street, Suite 5 Bellingham, WA		Log of Test Pit TP-1 (Page 1 of 1)					
Skagit County Jail Geotechnical Exploration Alf Christianson Site, E. Section & Kincaid St. Mt. Vernon, WA		Date Started : 9/12/13					
MTC Project No. 13B093-01		Date Completed : 9/12/13					
		Sampling Method : Grab Sample					
		Location : Approximately 50' E of S Gate, in grass					
		Logged By : JG					
Depth in Feet	USCS	GRAPHIC	DESCRIPTION	Samples	Water Level	Percent Moisture	% Finer #200 Sieve
0	OL		TOPSOIL - SANDY SILT, loose, grass roots, dry. Dark BROWN.				
1	SM		SILTY SAND, fine to medium grained, loose to medium dense, damp. Medium BROWN to BROWN-GRAY. Mottling begins.				
2							
3	ML		SANDY SILT, damp to moist, medium stiff, cohesive, variable coarse content. BROWN-GRAY with mottling. Upper contact has local band of dark brown silt 1-3" thick, contains charred wood remnants.

4							
5							
6	SP-SM		SILTY SAND to SAND WITH SILT, medium dense to loose, moist. Medium GRAY with mottling. Becomes medium GRAY, no visible mottling.				
7			Becomes saturated, seepage observed. Encountered large wood remnant, nondecomposed.				
8			Termination Depth: 7.8' Pit walls caving at end depth.				
9							
10

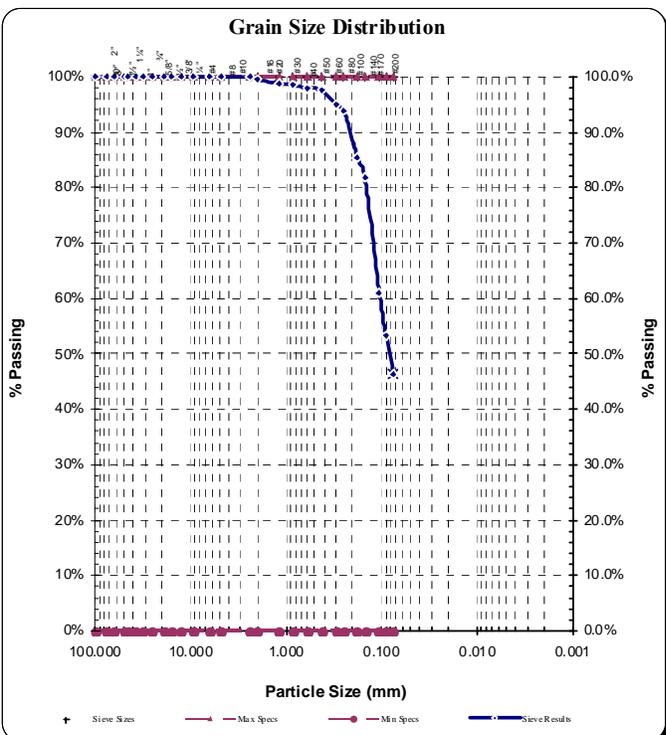
#40	0.425	98%	98%	100.0%	0.0%
#50	0.300		94%	100.0%	0.0%
#60	0.250		93%	100.0%	0.0%
#80	0.180	91%	91%	100.0%	0.0%
#100	0.150	88%	88%	100.0%	0.0%
#140	0.106		72%	100.0%	0.0%

#170	0.090		66%	100.0%	0.0%
#200	0.075	60.4%	60.4%	100.0%	0.0%

Grain-size distribution analyses were conducted in general accordance with ASTM Standard D422 on representative soil samples to determine the grain-size distribution of the on-site soil. The information gained from these analyses allows us to provide a description and classification of the in-place materials. In turn, this information helps us to understand how the in-place materials will react to conditions such as heavy seepage, traffic action, loading, potential liquefaction, and so forth. The results are presented in this Appendix.
