**Technical Memorandum
December 2, 2020**

Re: 2020 HGM Monitoring Summary at Waters/Wetlands Reserve Sites (Kulshan, Logan, Bakerview East and Bakerview West)

This document is an update to the annual HGM monitoring summary for the four waters/wetlands reserve sites in City of Mount Vernon.

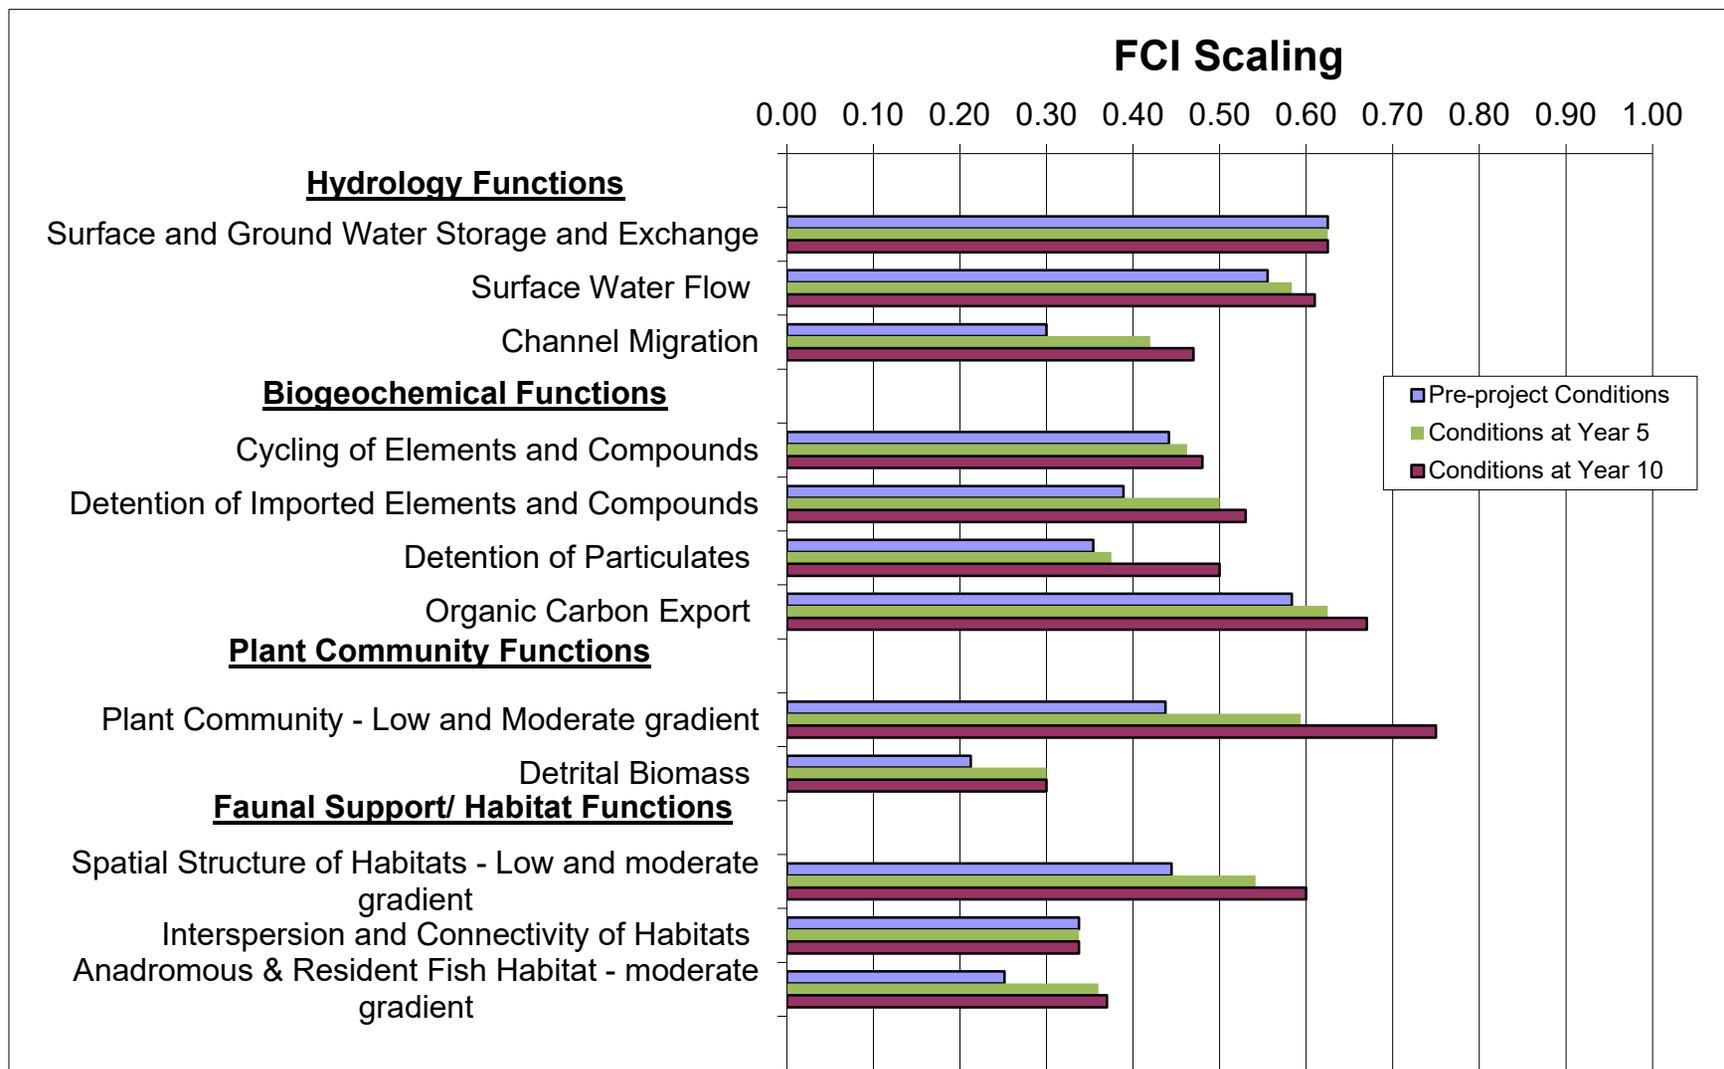
Figure 2. Bakerview Park West Riverine Wetland HGM Functional Capacity Index (FCI) scaling comparing pre-project, Year 5, and Year 10.

This year, 2020, is the twelfth year following installation of the Bakerview West mitigation area, so it is beyond the required 10-year monitoring period. A final summary report was completed for that site dated August 31, 2018 (7K 2018). The Bakerview west site will not be fully re-evaluated in future years as the project had a 10-year monitoring period unless additional phases of planting are undertaken at this site. We aim to continue brief site visit to this mitigation area and to run the HGM assessment every 5 years.

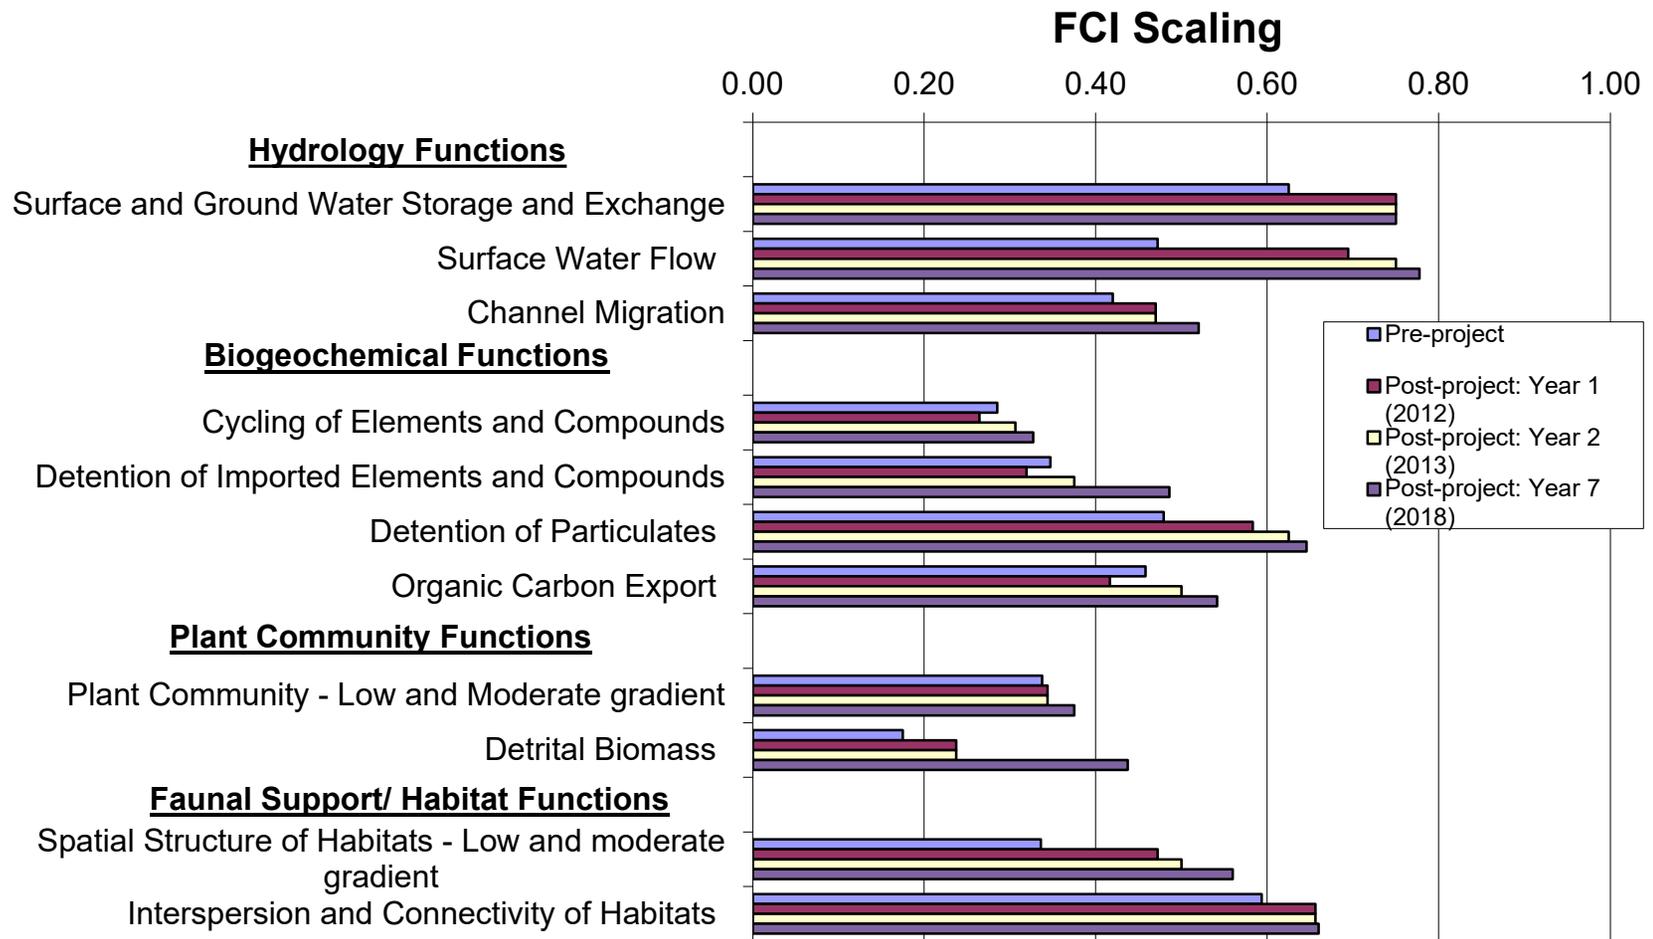
Figure 3. Logan Creek Riverine Wetland HGM Functional Capacity Index (FCI) scaling comparing pre-project and Year 7. Note there are not changes to FCI Scaling in 2020 (Year 9) so this figure was not updated.

At Logan Creek in 2018, the HGM review exhibited lift in several variables as the installed trees are reaching tree canopy height. No additional change in variables was observed in 2019 or 2020. In 2020, the supplemental plant stock appears to be healthy and is showing good survival. Trees and shrubs are reaching canopy thresholds and are starting to provide a more contiguous habitat in the riparian area. As the plant communities continue to develop, lift is expected in several additional functions.

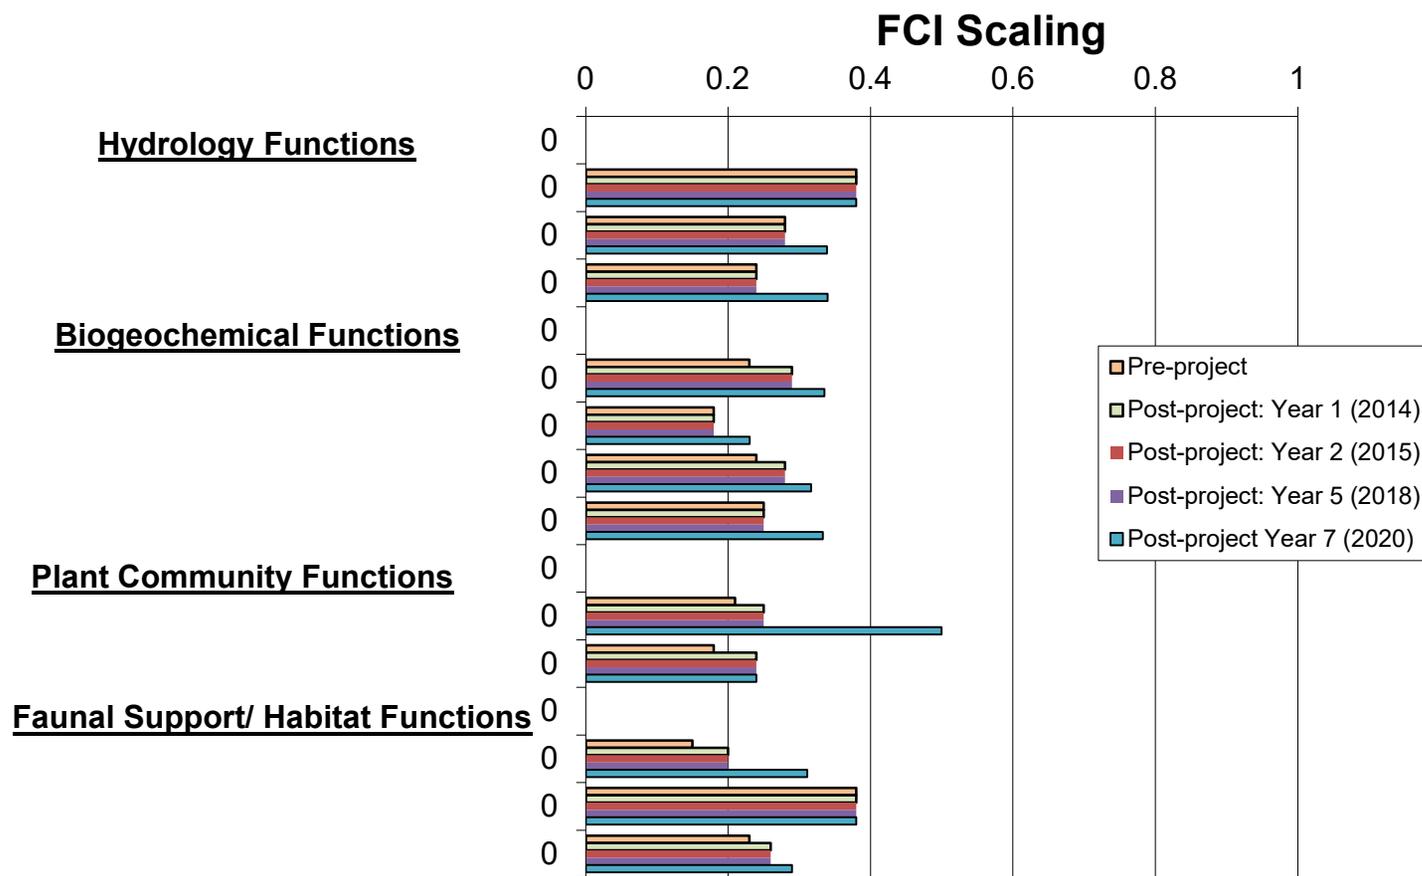
Figure 4. Kulshan Creek Riverine Wetland HGM Functional Capacity Index (FCI) scaling comparing pre-project, Year 1, 2, 5 and 7.

Slight increases were realized in 9 of 12 functions at Kulshan Creek from baseline to Year 7 (2020) as additional plant community thresholds are been met. Trees installed at this site starting to meet height thresholds to realize lift in plant community functions.

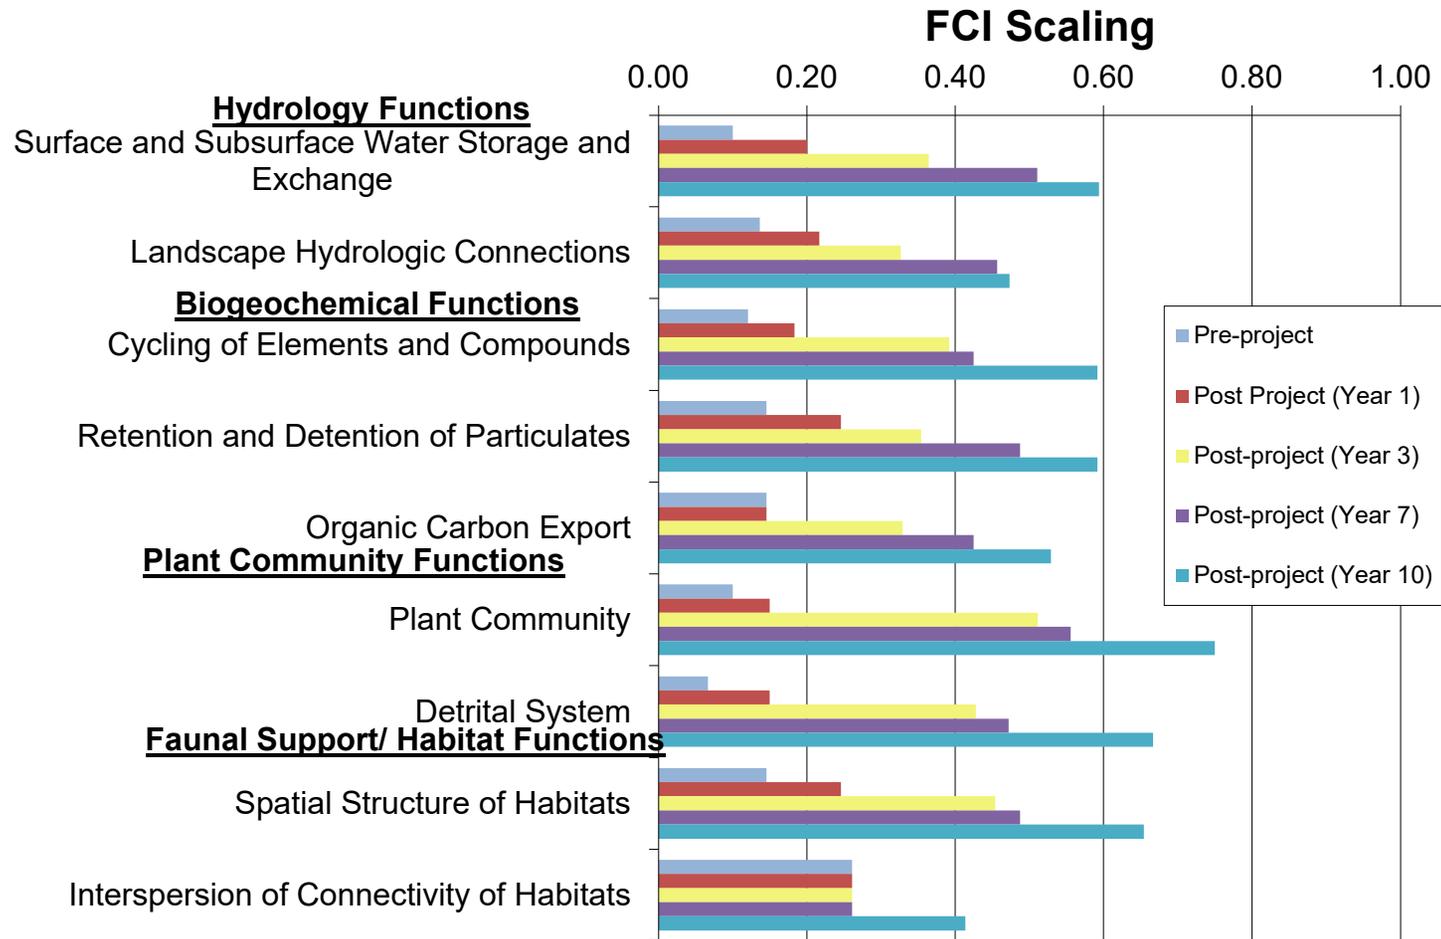
Figure 5. Site trajectory for HGM functional assessment Functional Capacity Indices pre-project, 1st year (2011), 3rd year (2013), and 5th and 8th year (2015 and 2018) and 10th year (2020) post-project at Bakerview Park East slope wetland restoration.

There were increases in variable scores and functions at Bakerview Park East in 2020 as tree and shrub growth meets additional thresholds. Alders were thinned on the west part of the Bakerview East mitigation area by the Shelterbelt team to reduce competition with planted stock while preserving cover to reduce weed pressure. Tree and shrub cover is creating a larger and more contiguous native habitat patch that prior to restoration. This site has developed well and is in line with performance standards.

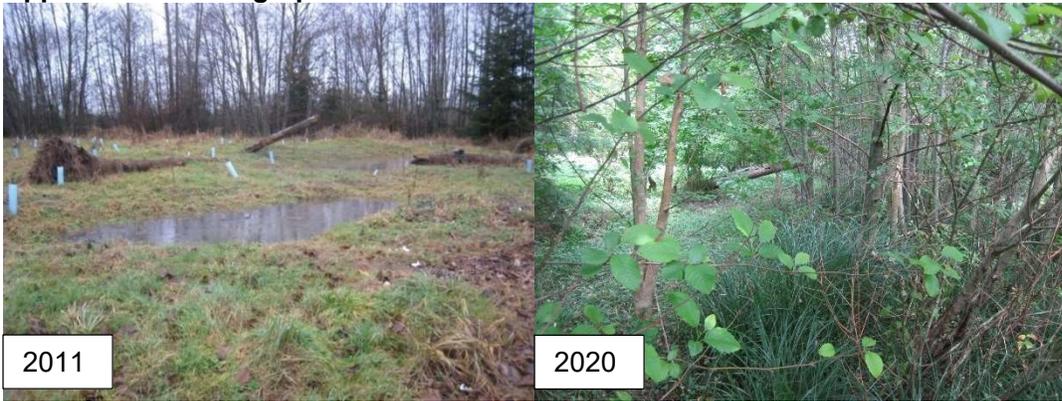
Bakerview East Year 1 versus Year 10 site condition at the northeast end of project area.

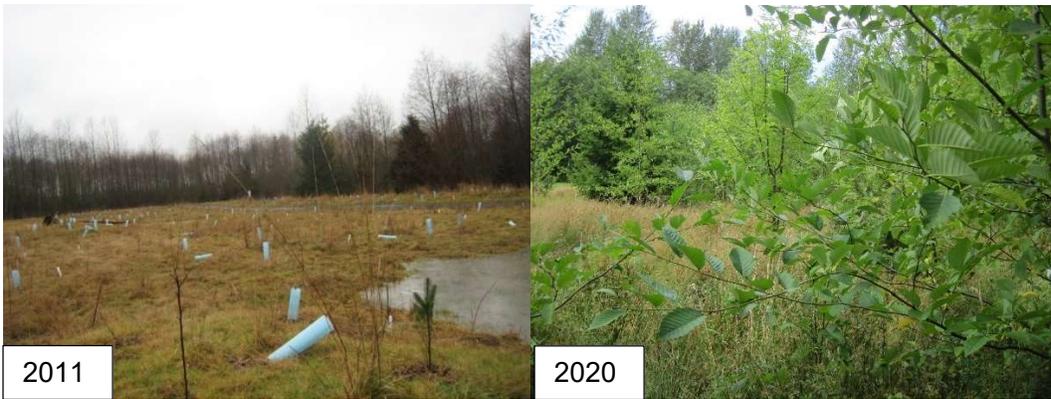
In 2020, survival of these remains high. Additionally, note that Shelterbelt completed alder thinning in the western portion of Bakerview East mitigation area in 2020.

Bakerview East Year 1 versus Year 10 site condition at the west end of project area.

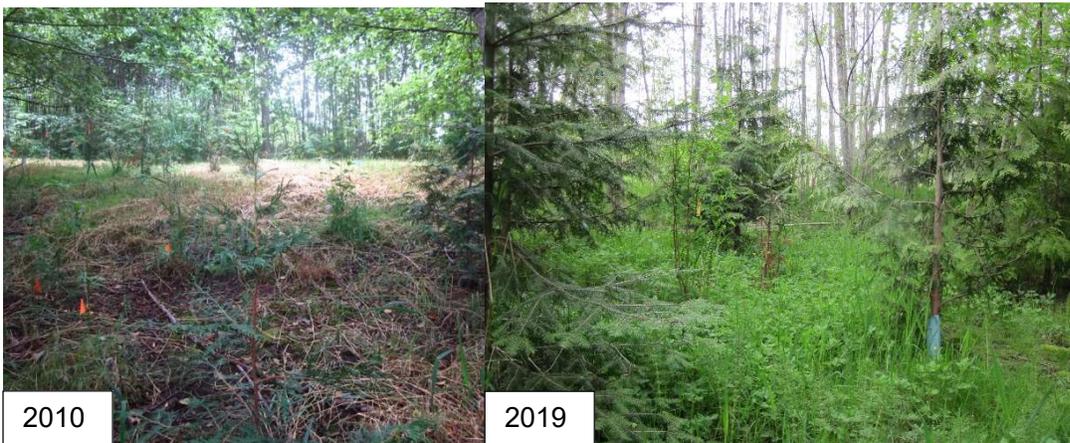
Bakerview West Year 5 versus Year 10 site condition

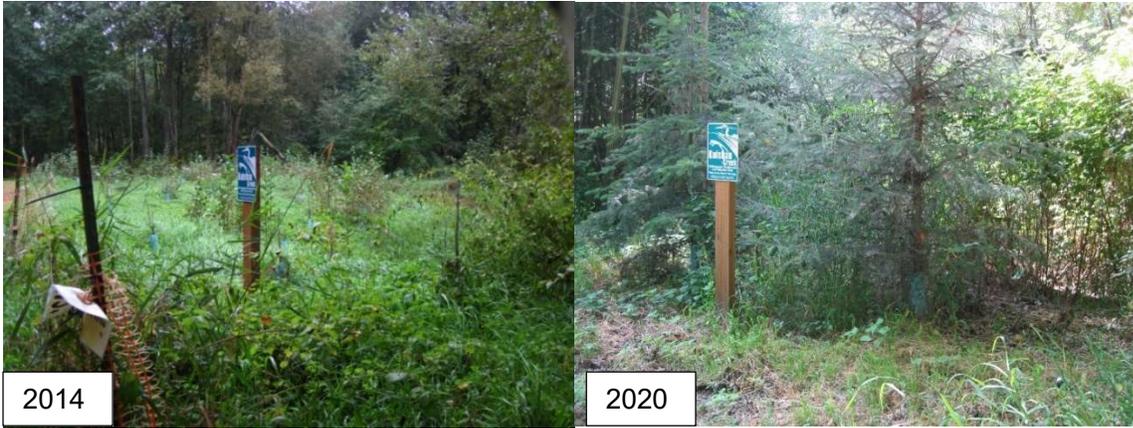
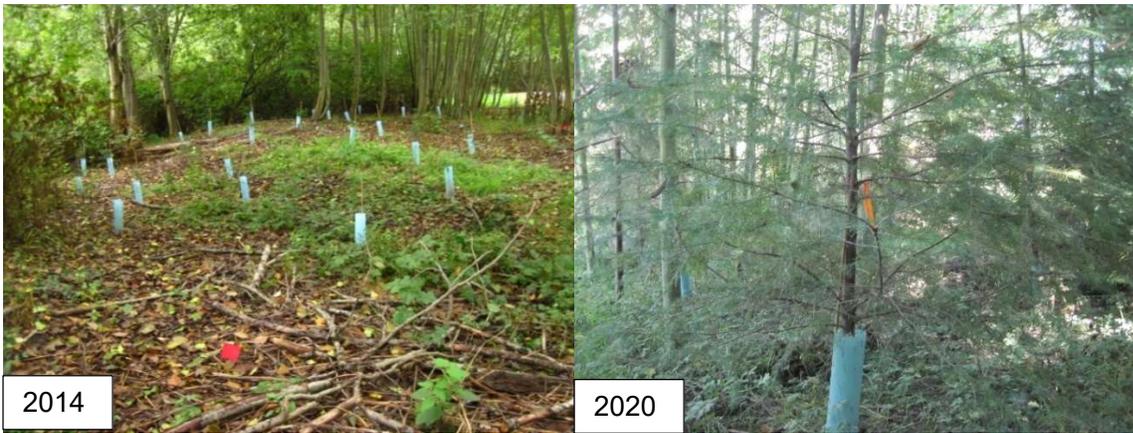
Kulshan Creek Year 1 versus Year 7

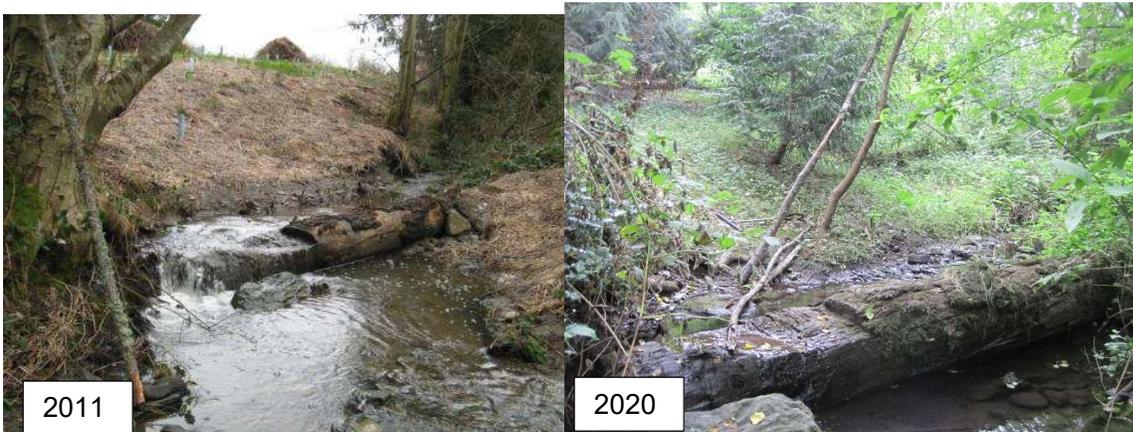
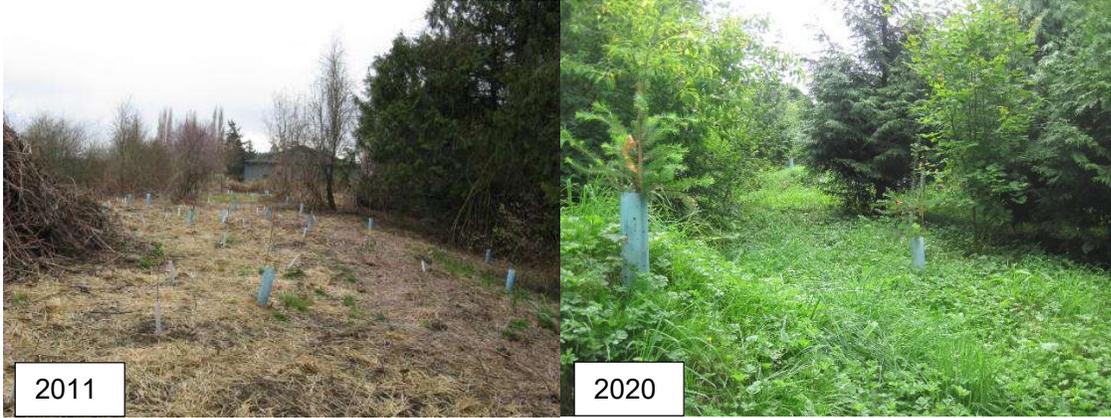
Logan Creek Year 1 versus Year 9
