## **Technical Report - Supporting Data and Analysis for Skagit River RFIS Appeal**

March 2011

**Skagit County, Washington**

Pacific International Engineering, PLLC

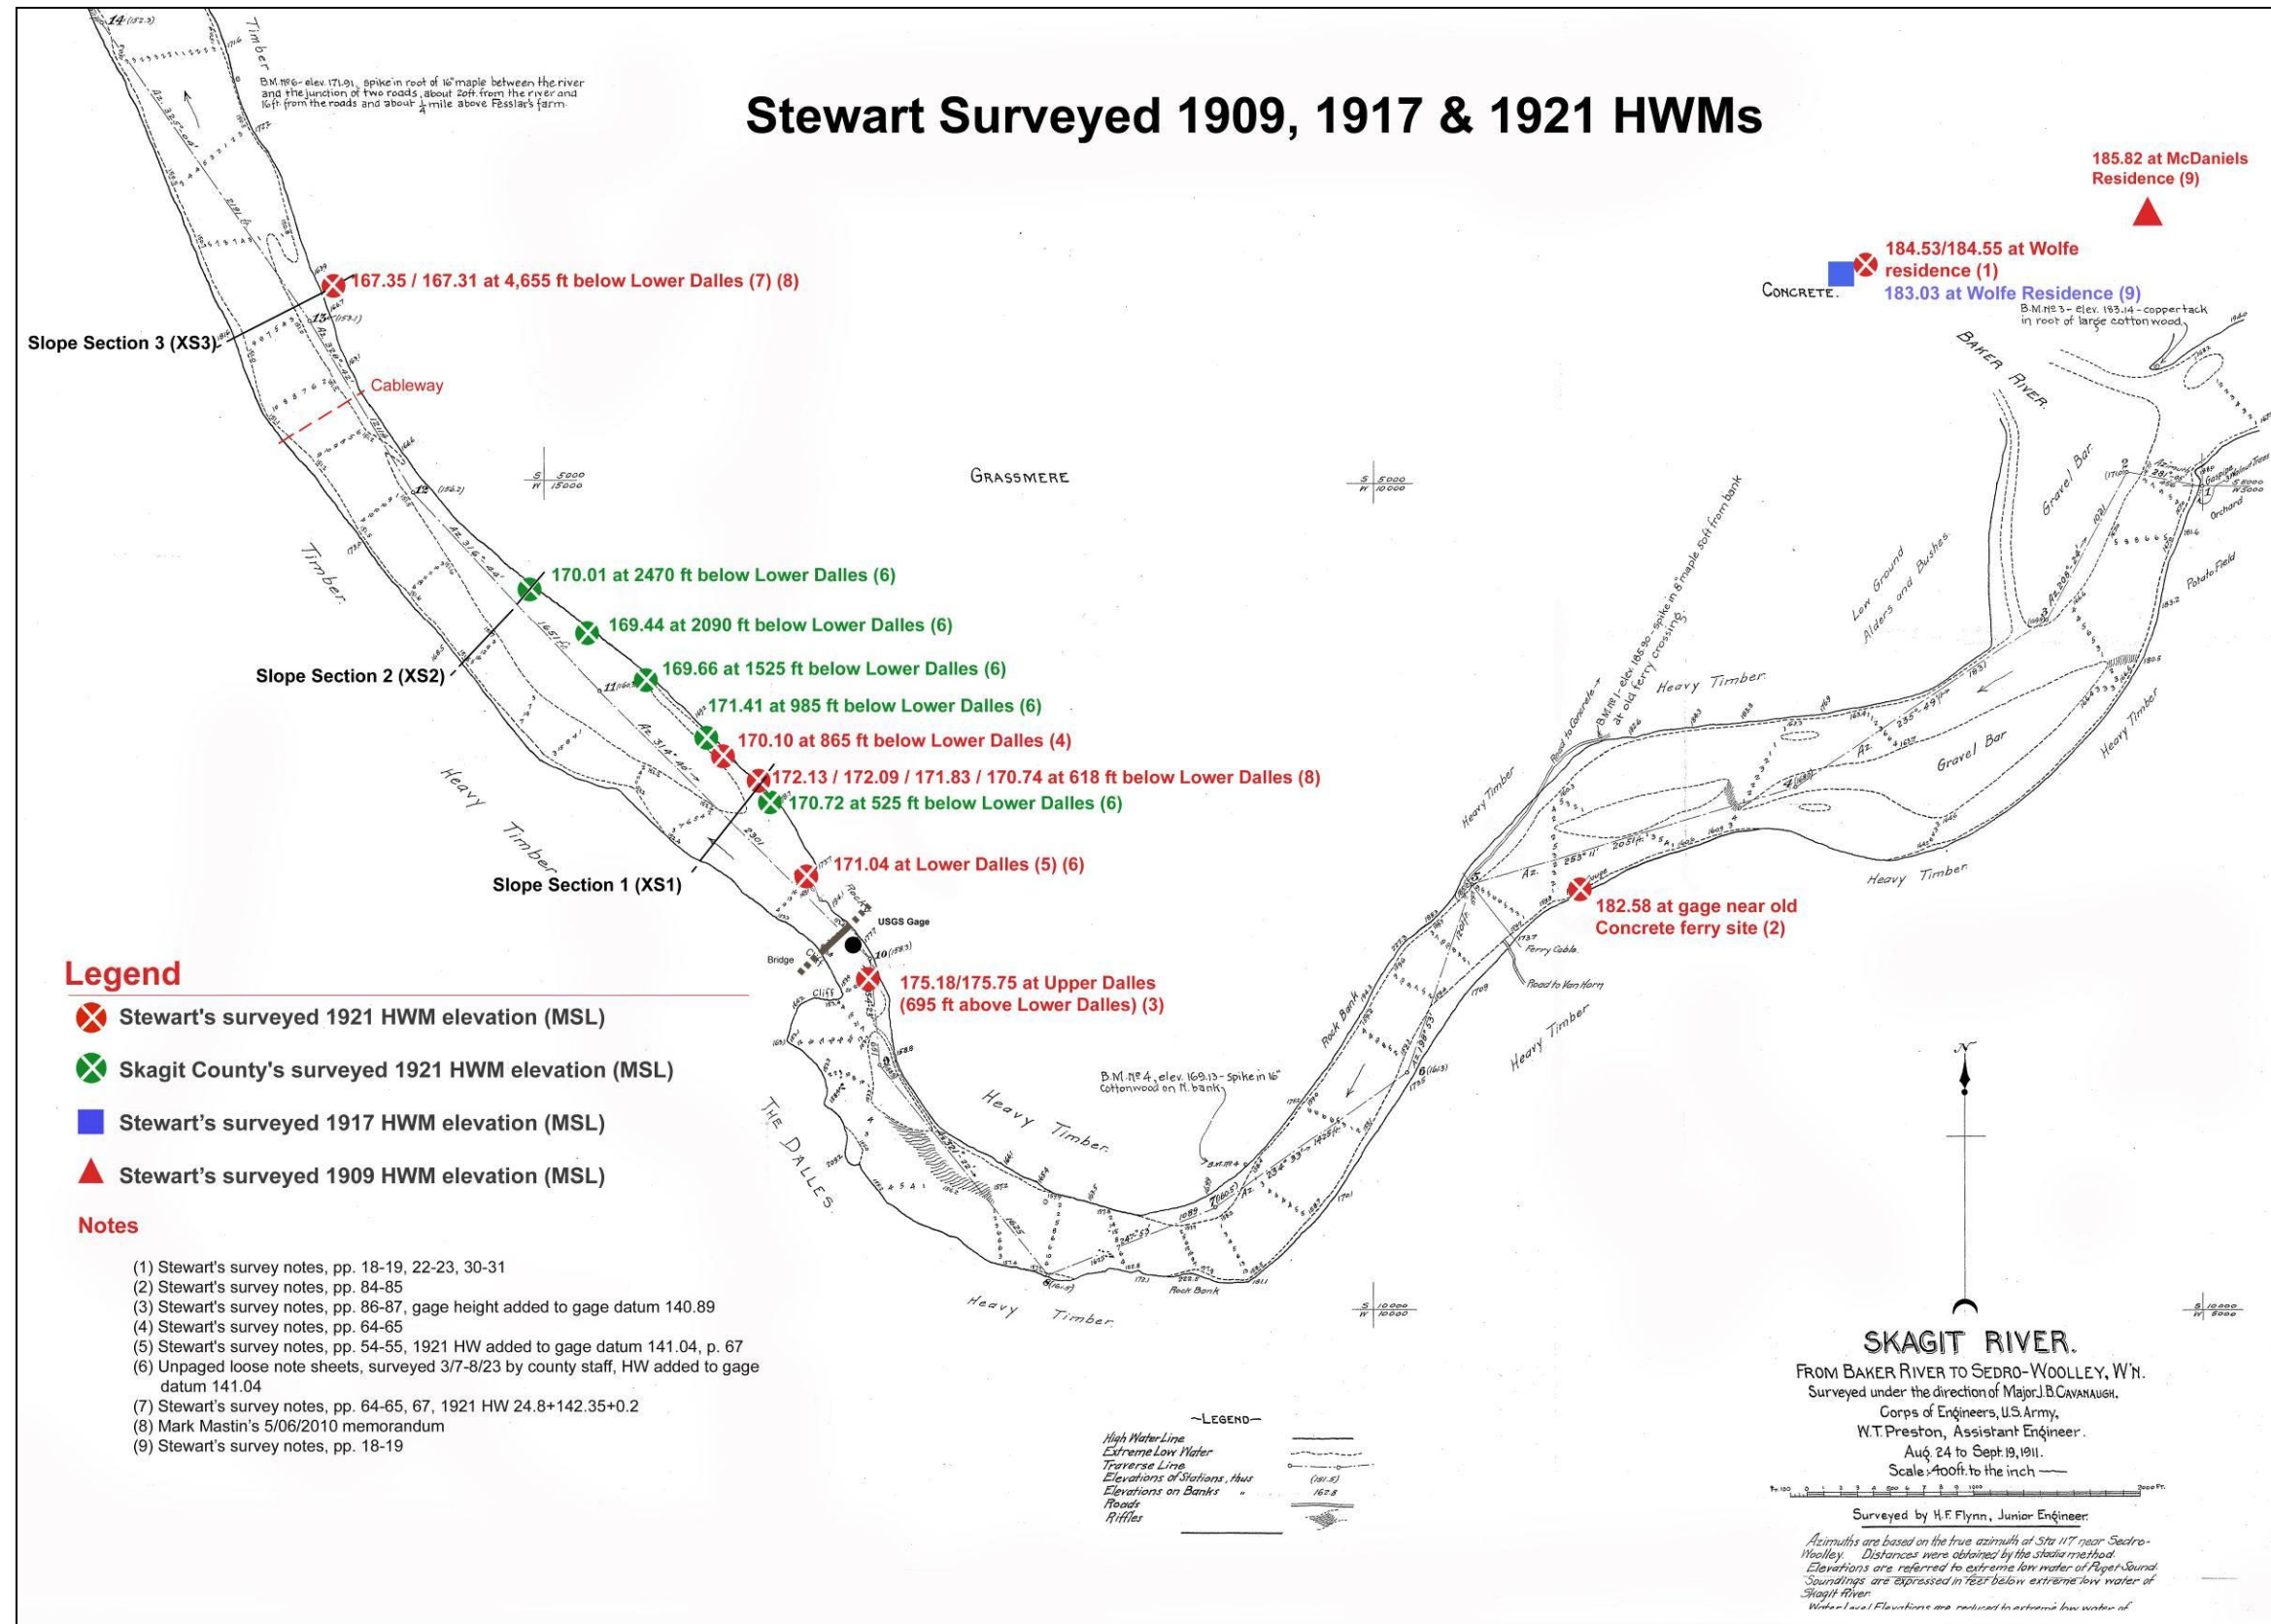
Figure 1. Stewart Surveyed 1909, 1917 and 1921 Highwater Marks (in feet, MSL) in Concrete Area

Documentation of Stewart's surveyed historical flood marks are presented in his hand-written field notes (Stewart, 1922-23). Figures 1 and 2 show the location and the water surface elevations of Stewart-surveyed flood marks (or highwater marks, HWMs) in the Concrete area and in the Hamilton-Lyman area, respectively. Figure 2 also shows over a dozen other observed 1909 and 1921 flood marks along Lyman-Hamilton Road and along the old Great Northern Railroad (GNRR) parallel to Lyman-Hamilton Road (for discussion of these flood marks, see Section 2.2.3). These flood marks correlate well with Stewart-surveyed historical flood marks in the area.

Stewart's 1921 HWMs shown in Figure 1 are 175.18 and 175.75 at the upper Dalles and 171.04 at the lower Dalles, indicating a drop of 4.14 and 4.71 feet (averaging 4.5 feet) at the crest of the 1921 flood between the upper and the lower Dalles. Stewart noted that the upper Dalles is 695 ft above the lower end of the Dalles (Stewart's survey notes, p. 62).

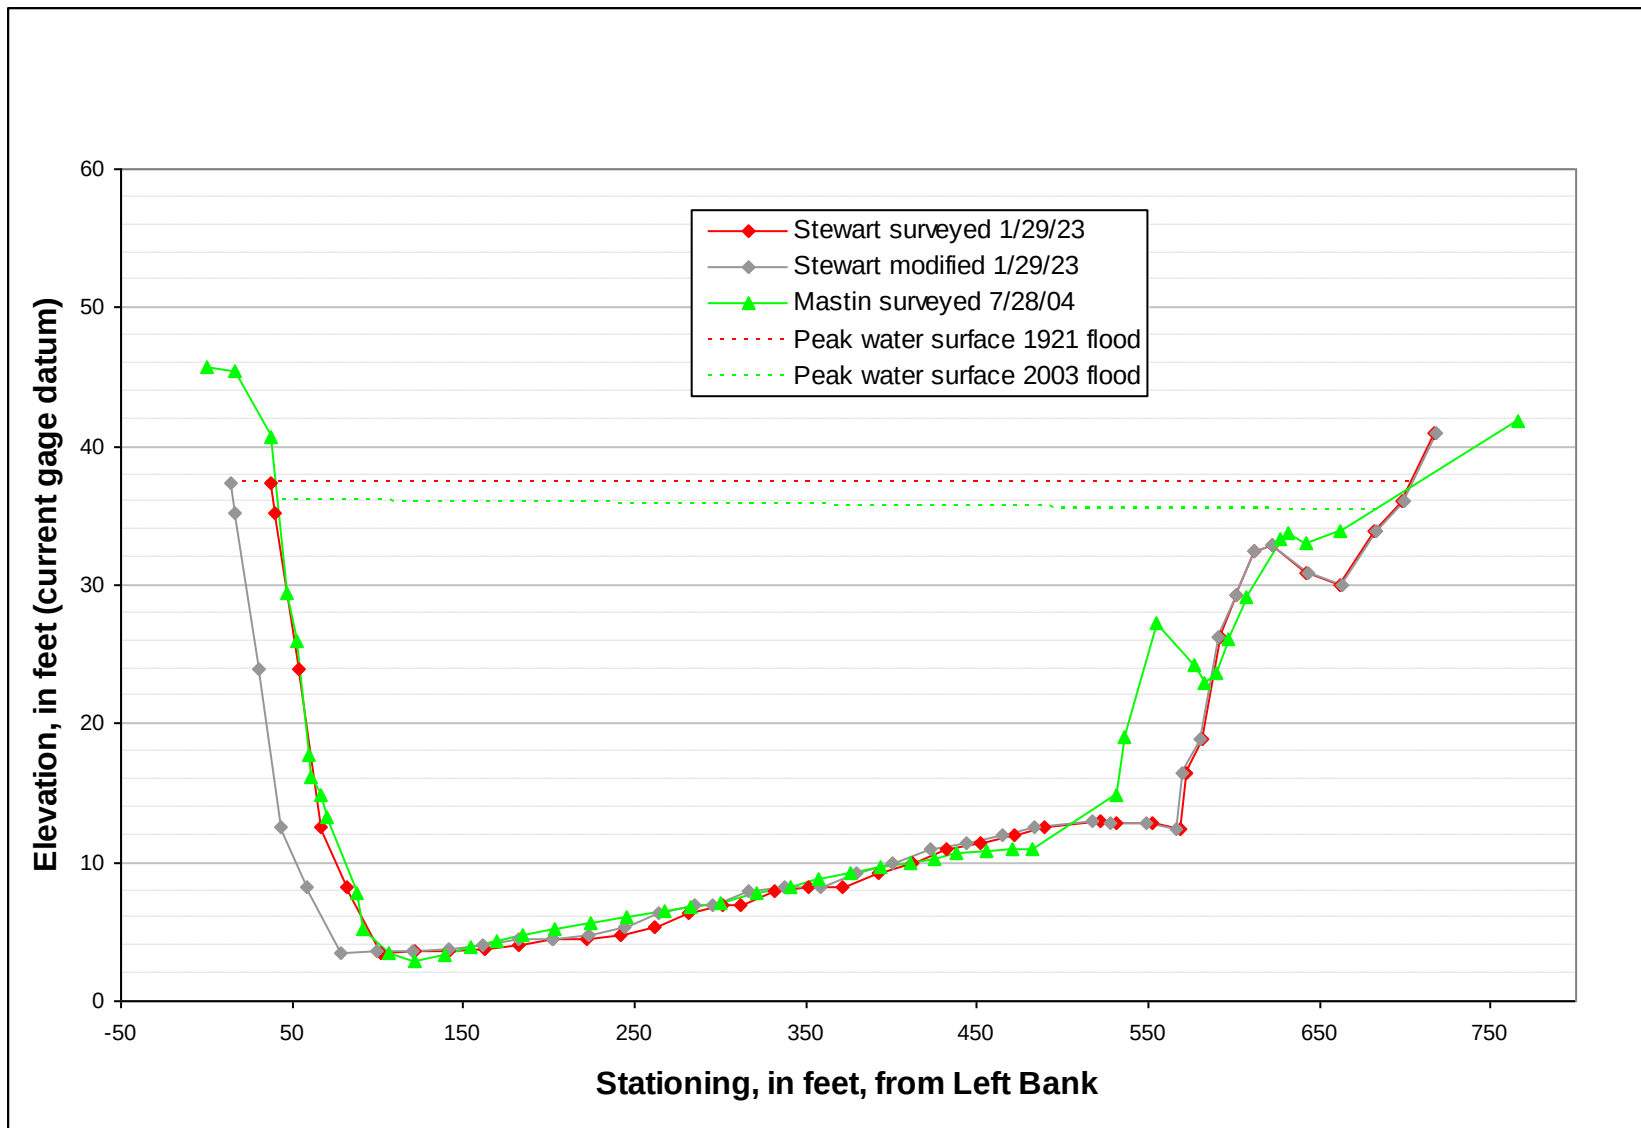
Figure 8 shows plots of Stewart's originally surveyed and later-modified lower slope section. In 2004, the USGS (Mastin and his field crew) surveyed this section. The USGS 2004-surveyed lower slope section is also shown in the figure for a comparison. This comparison indicates that Stewart's originally surveyed section appears accurate, matching the channel width and bottom elevations with the 2004-surveyed section better than his modified section. This comparison assumes that the 1923 and 2004 surveys are approximately at the same location, and that the change in cross section from 1923 to 2004 at this location is not significant.

**Figure 8. Slope Section XS3 – Skagit River near Concrete, WA**

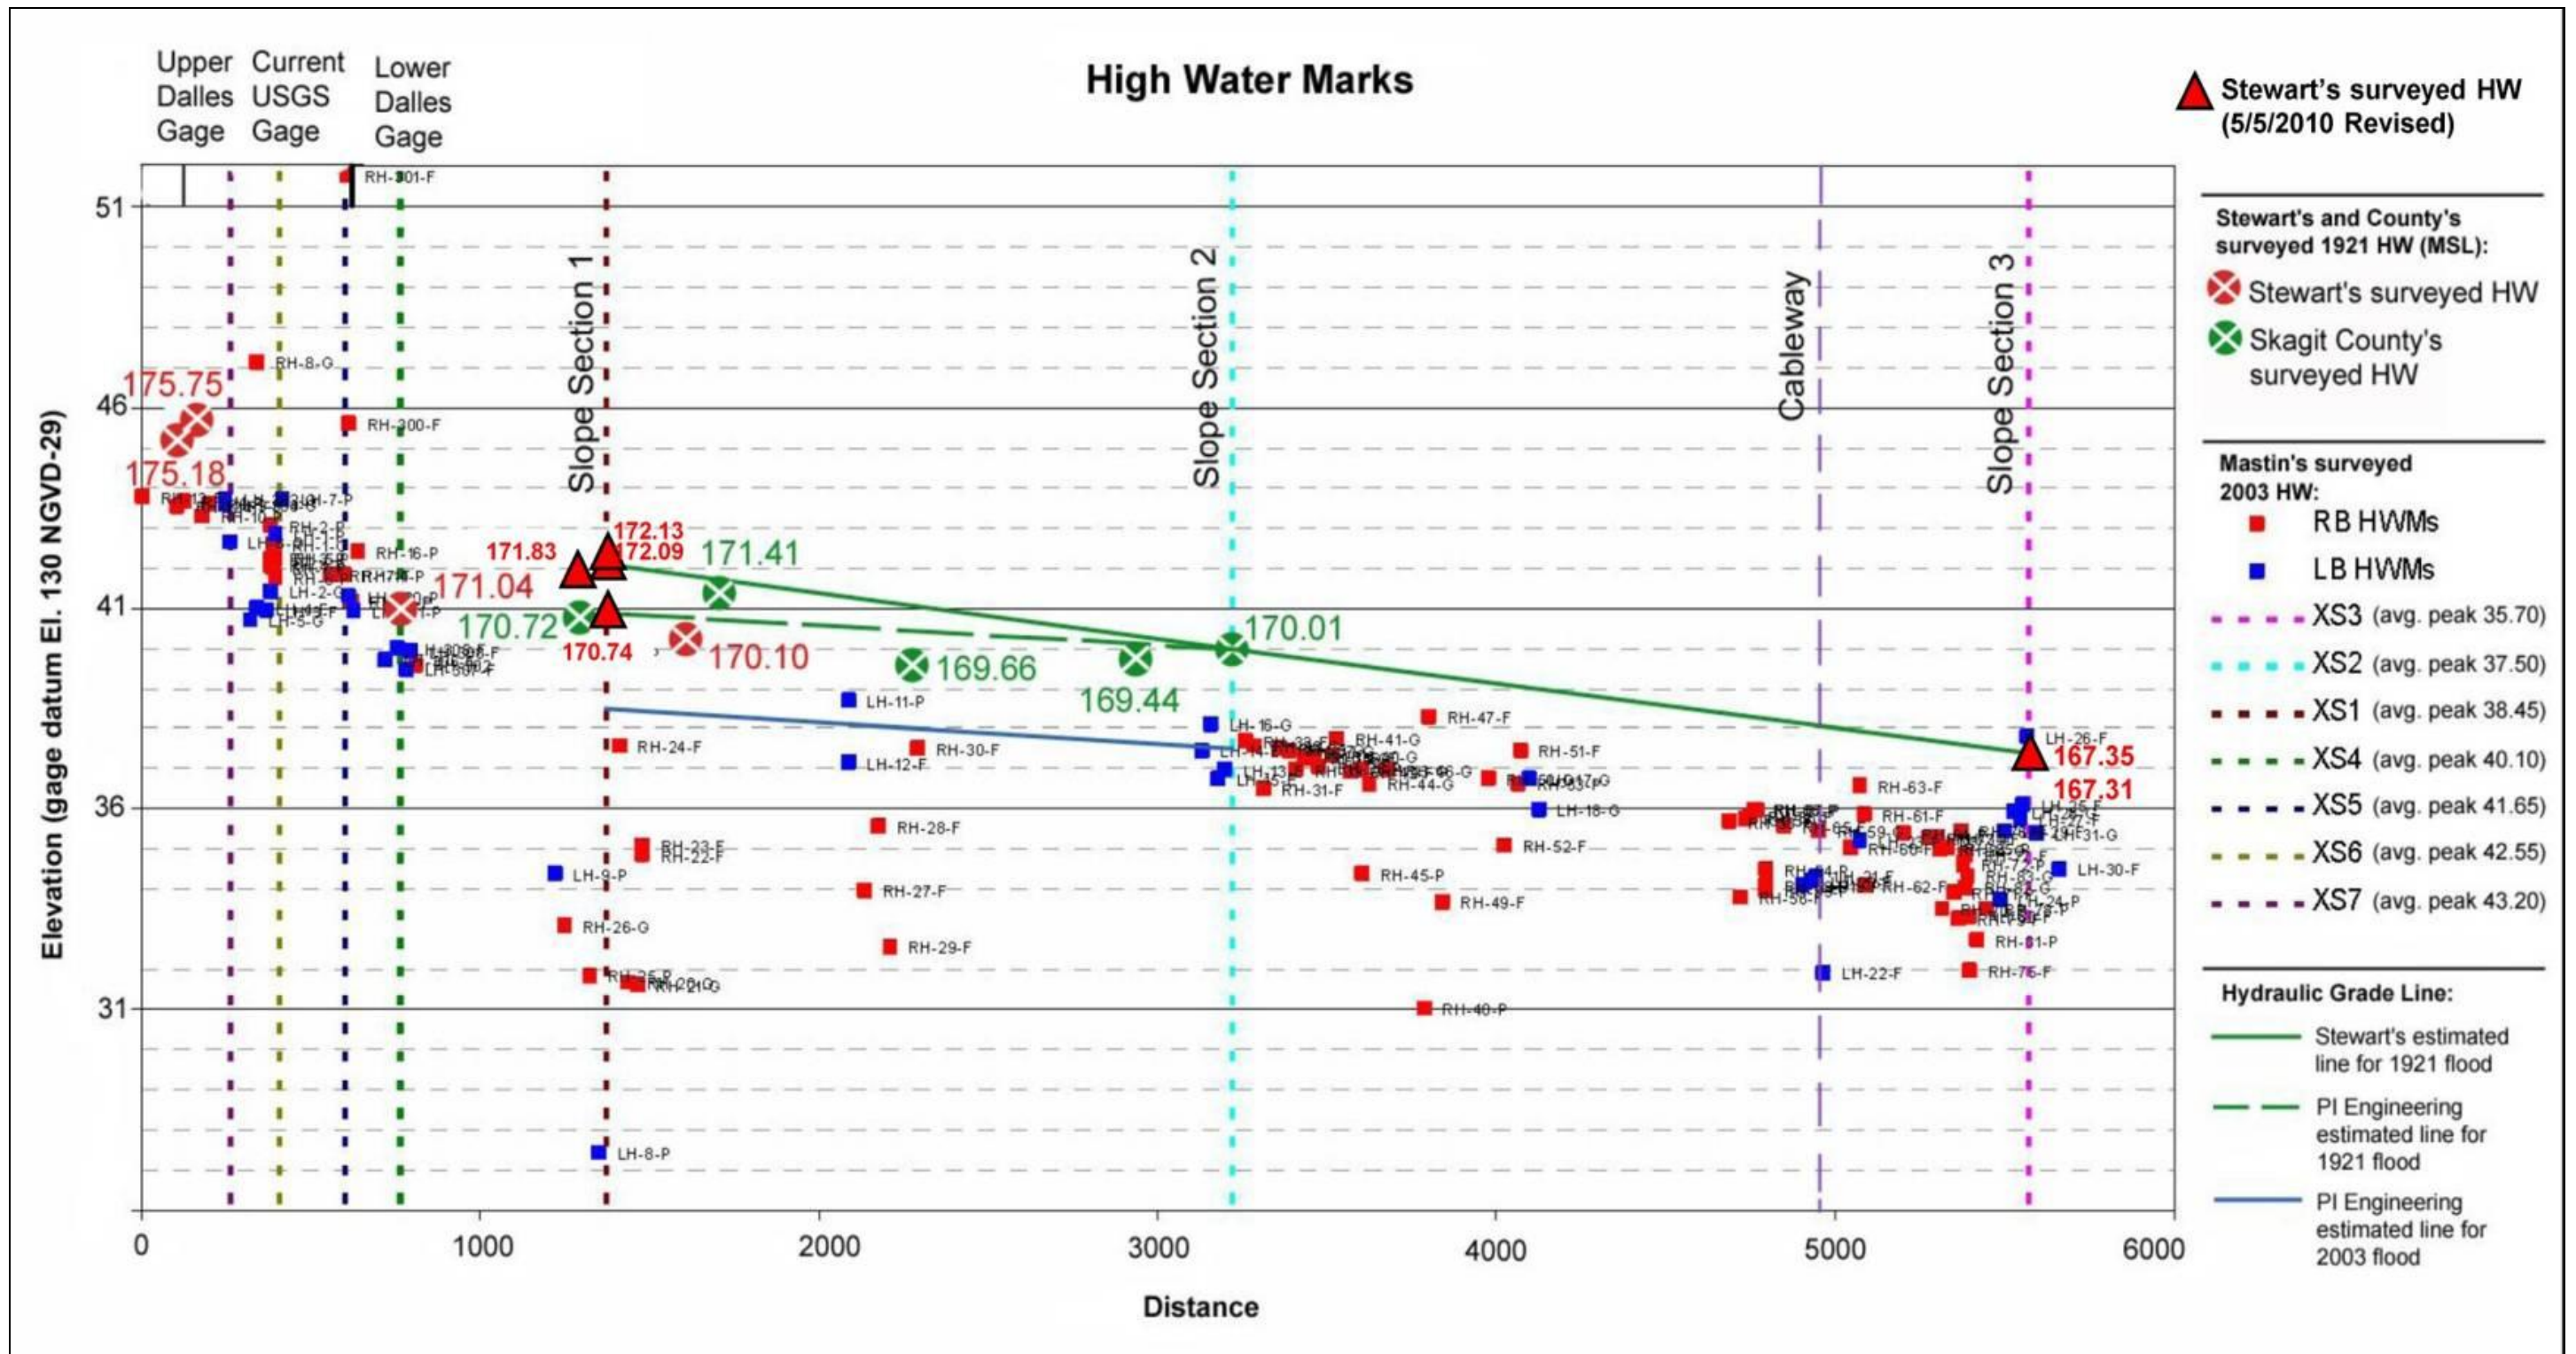
Figure 9. 1921 and 2003 flood high water marks surveyed by Stewart (in 1922-23) and USGS (in summer 2004)

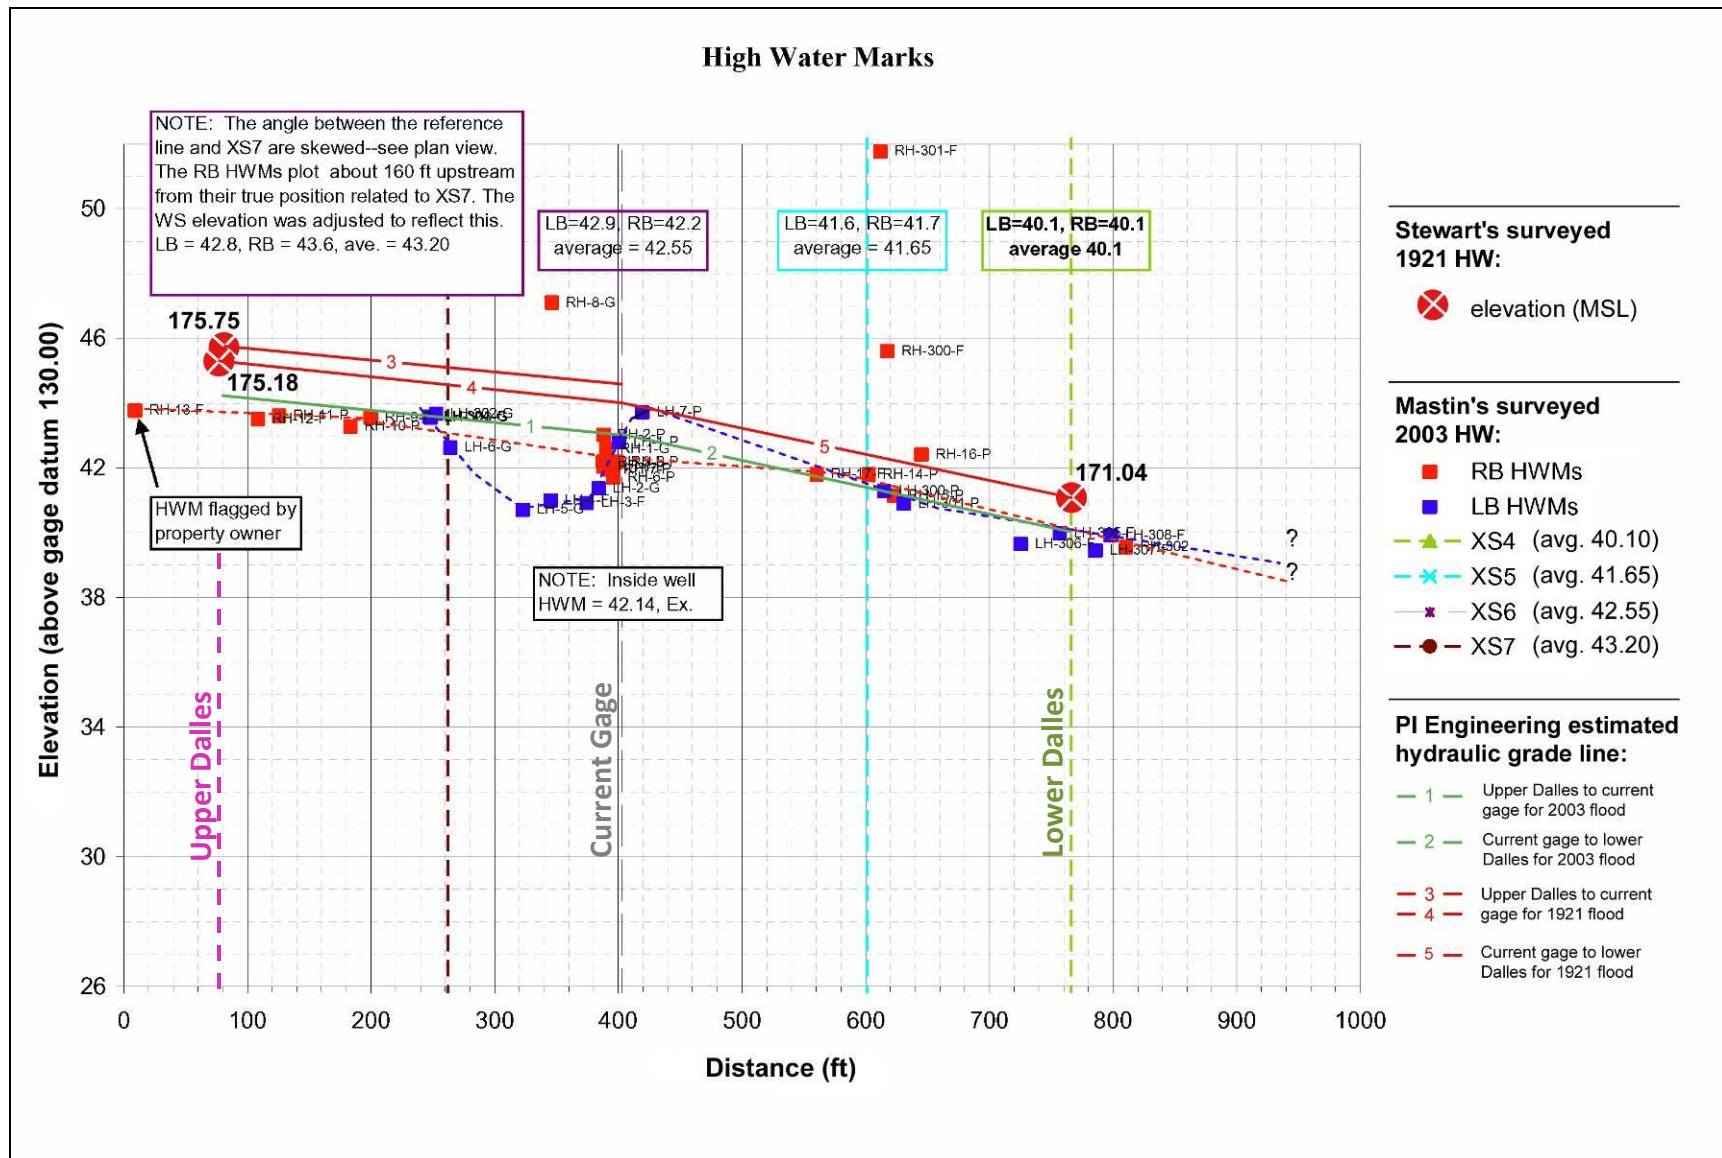
Three Stewart-surveyed 1921 HWMs (expressed in MSL) are shown in Figure 10 (an enlarged plot of Figure 9 showing only HWMs in the Dalles gorge), including 175.18 and 175.75 at his upper Dalles gage and 171.04 at his lower Dalles gage. Stewart noted that the upper Dalles is 695 ft above the lower end of the Dalles (Stewart's survey notes, p. 62). Figure 10 shows that the current gage (XS6) is located approximately 365 ft above the lower Dalles (XS4). This leads to an estimated distance of 330 ft between Stewart's upper Dalles gage and the current gage (which is more than "about 200 feet above present gage" stated incorrectly by the USGS-published Water Supply Paper 612 (USGS 1925, p. 62)).

Figure 10. 1921 and 2003 HWMs in the Dalles gorge (original source of data: USGS-provided spreadsheet – Concrete\_03\_SAM.xls)

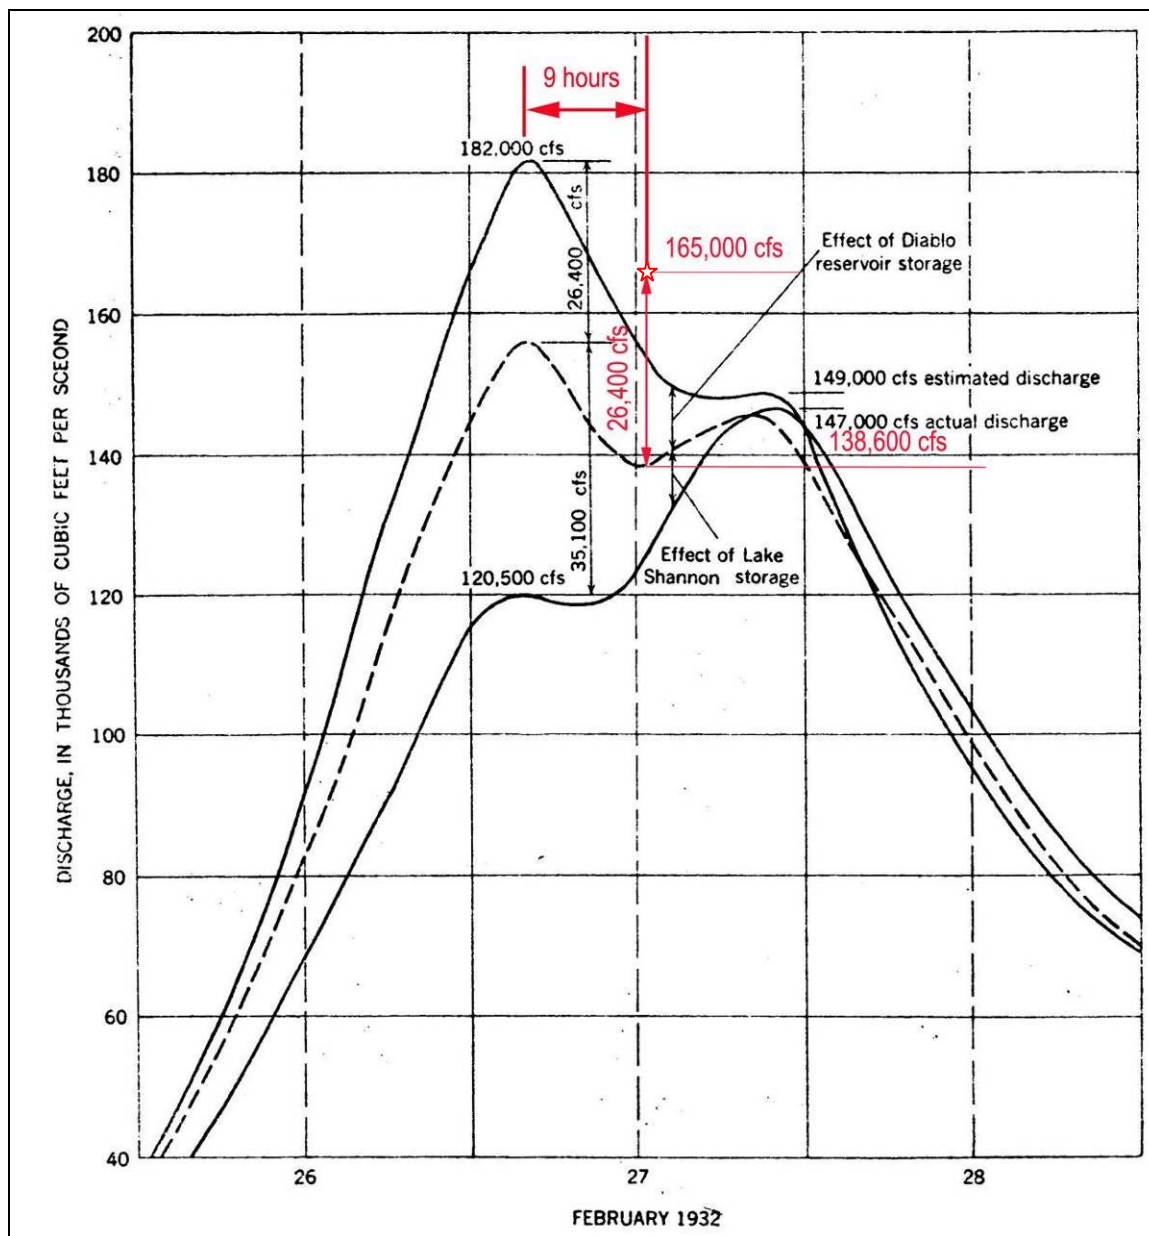
**Figure 17. USGS published estimate of 1932 unregulated flood peak discharge at Concrete (source of data: Figure 4 – Hydrographs showing effect of dams on flood peak, USGS 1961)**

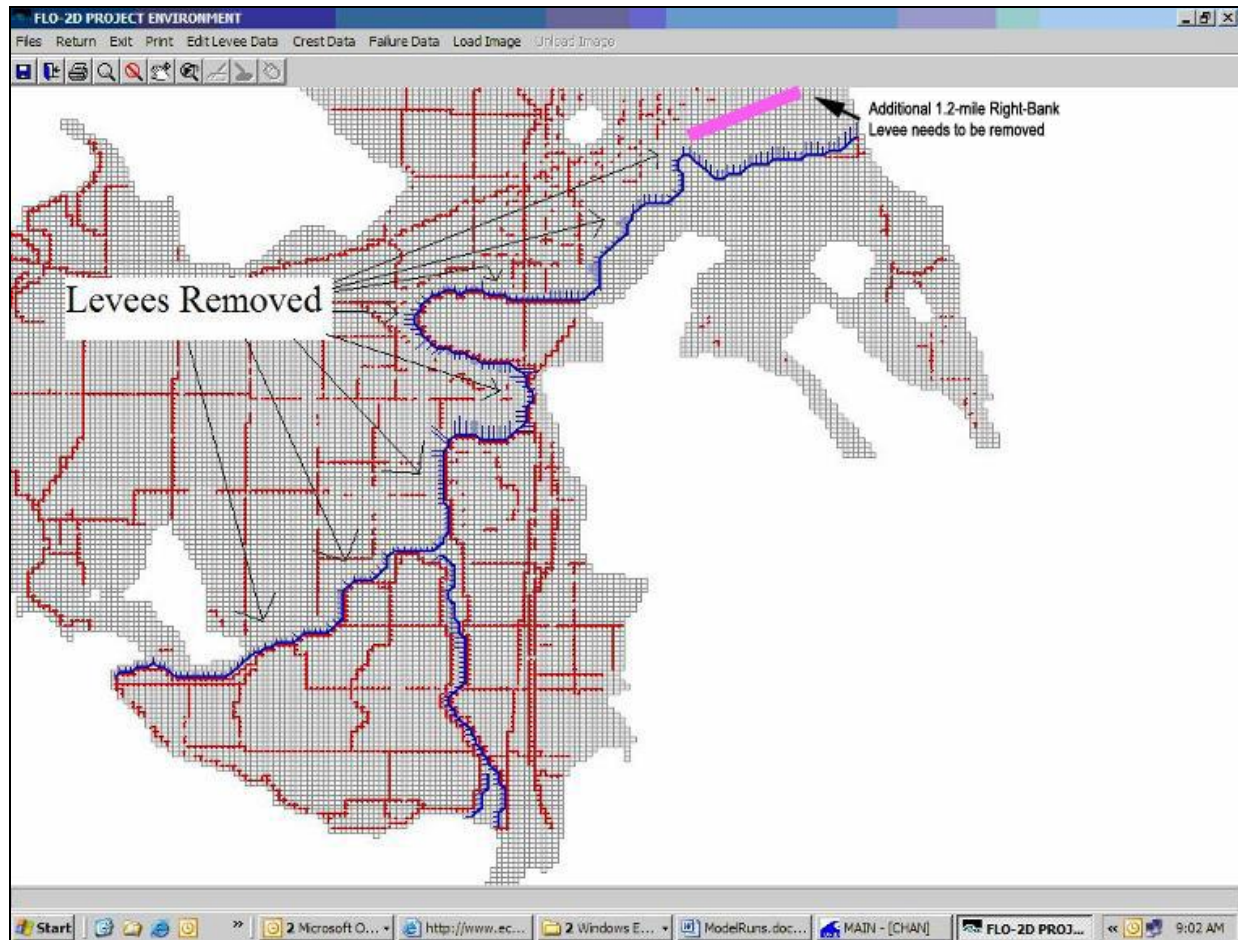
**Figure 22. Right Bank Levees on Mainstem and North Fork Skagit River Removed While All Other Levees Remain Intact** (original source: Figure 9, COE 2009)

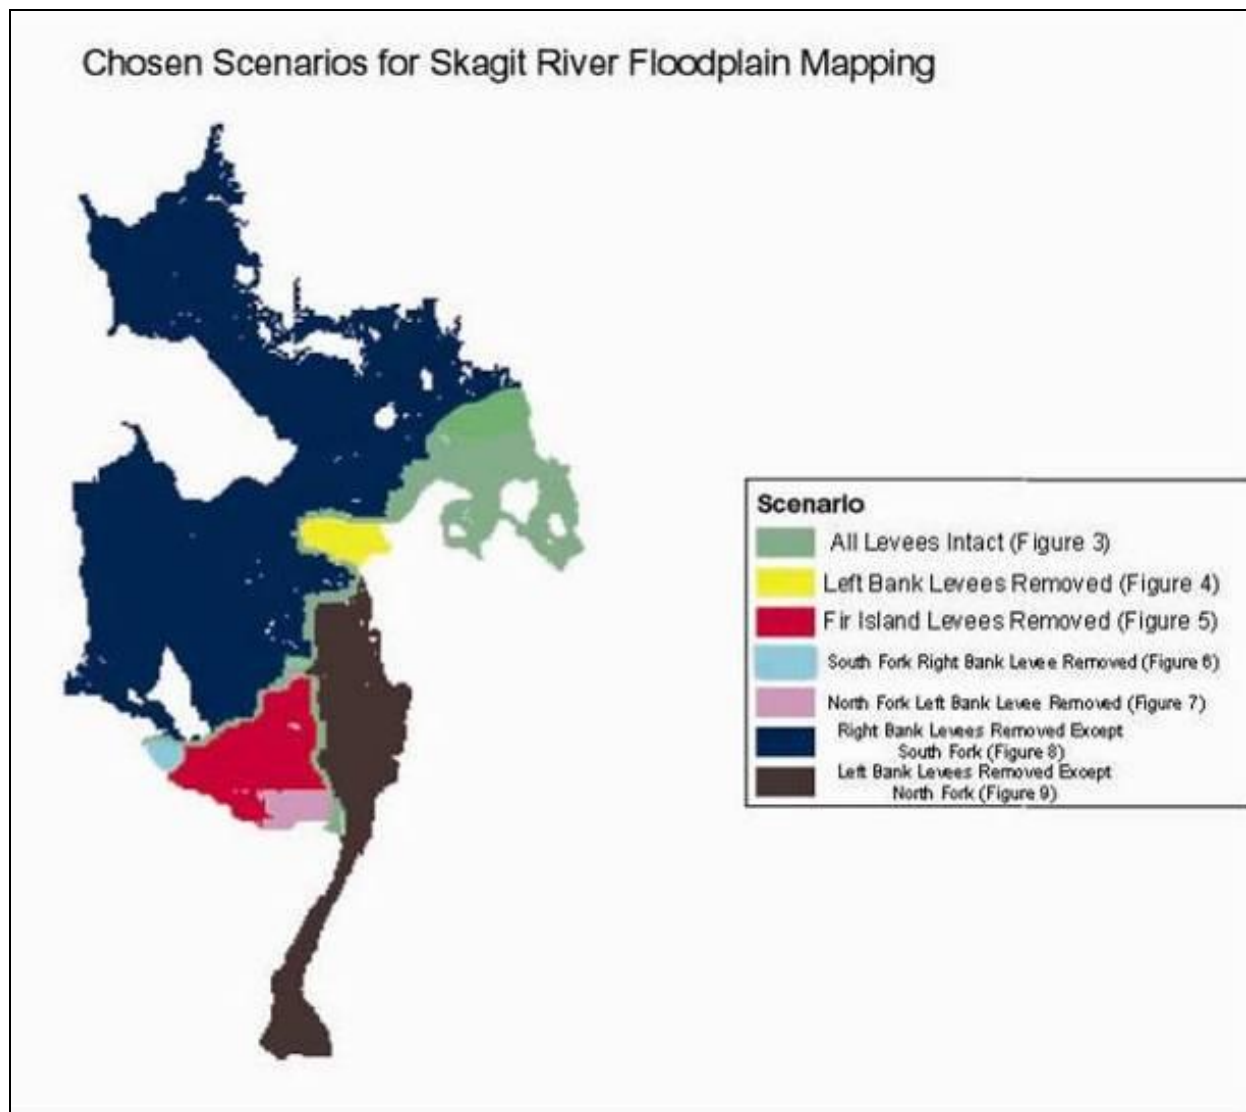
**Figure 23. Depiction of the Floodplain Scenario Location of Implementation (original source: Figure 11, COE 2009)**

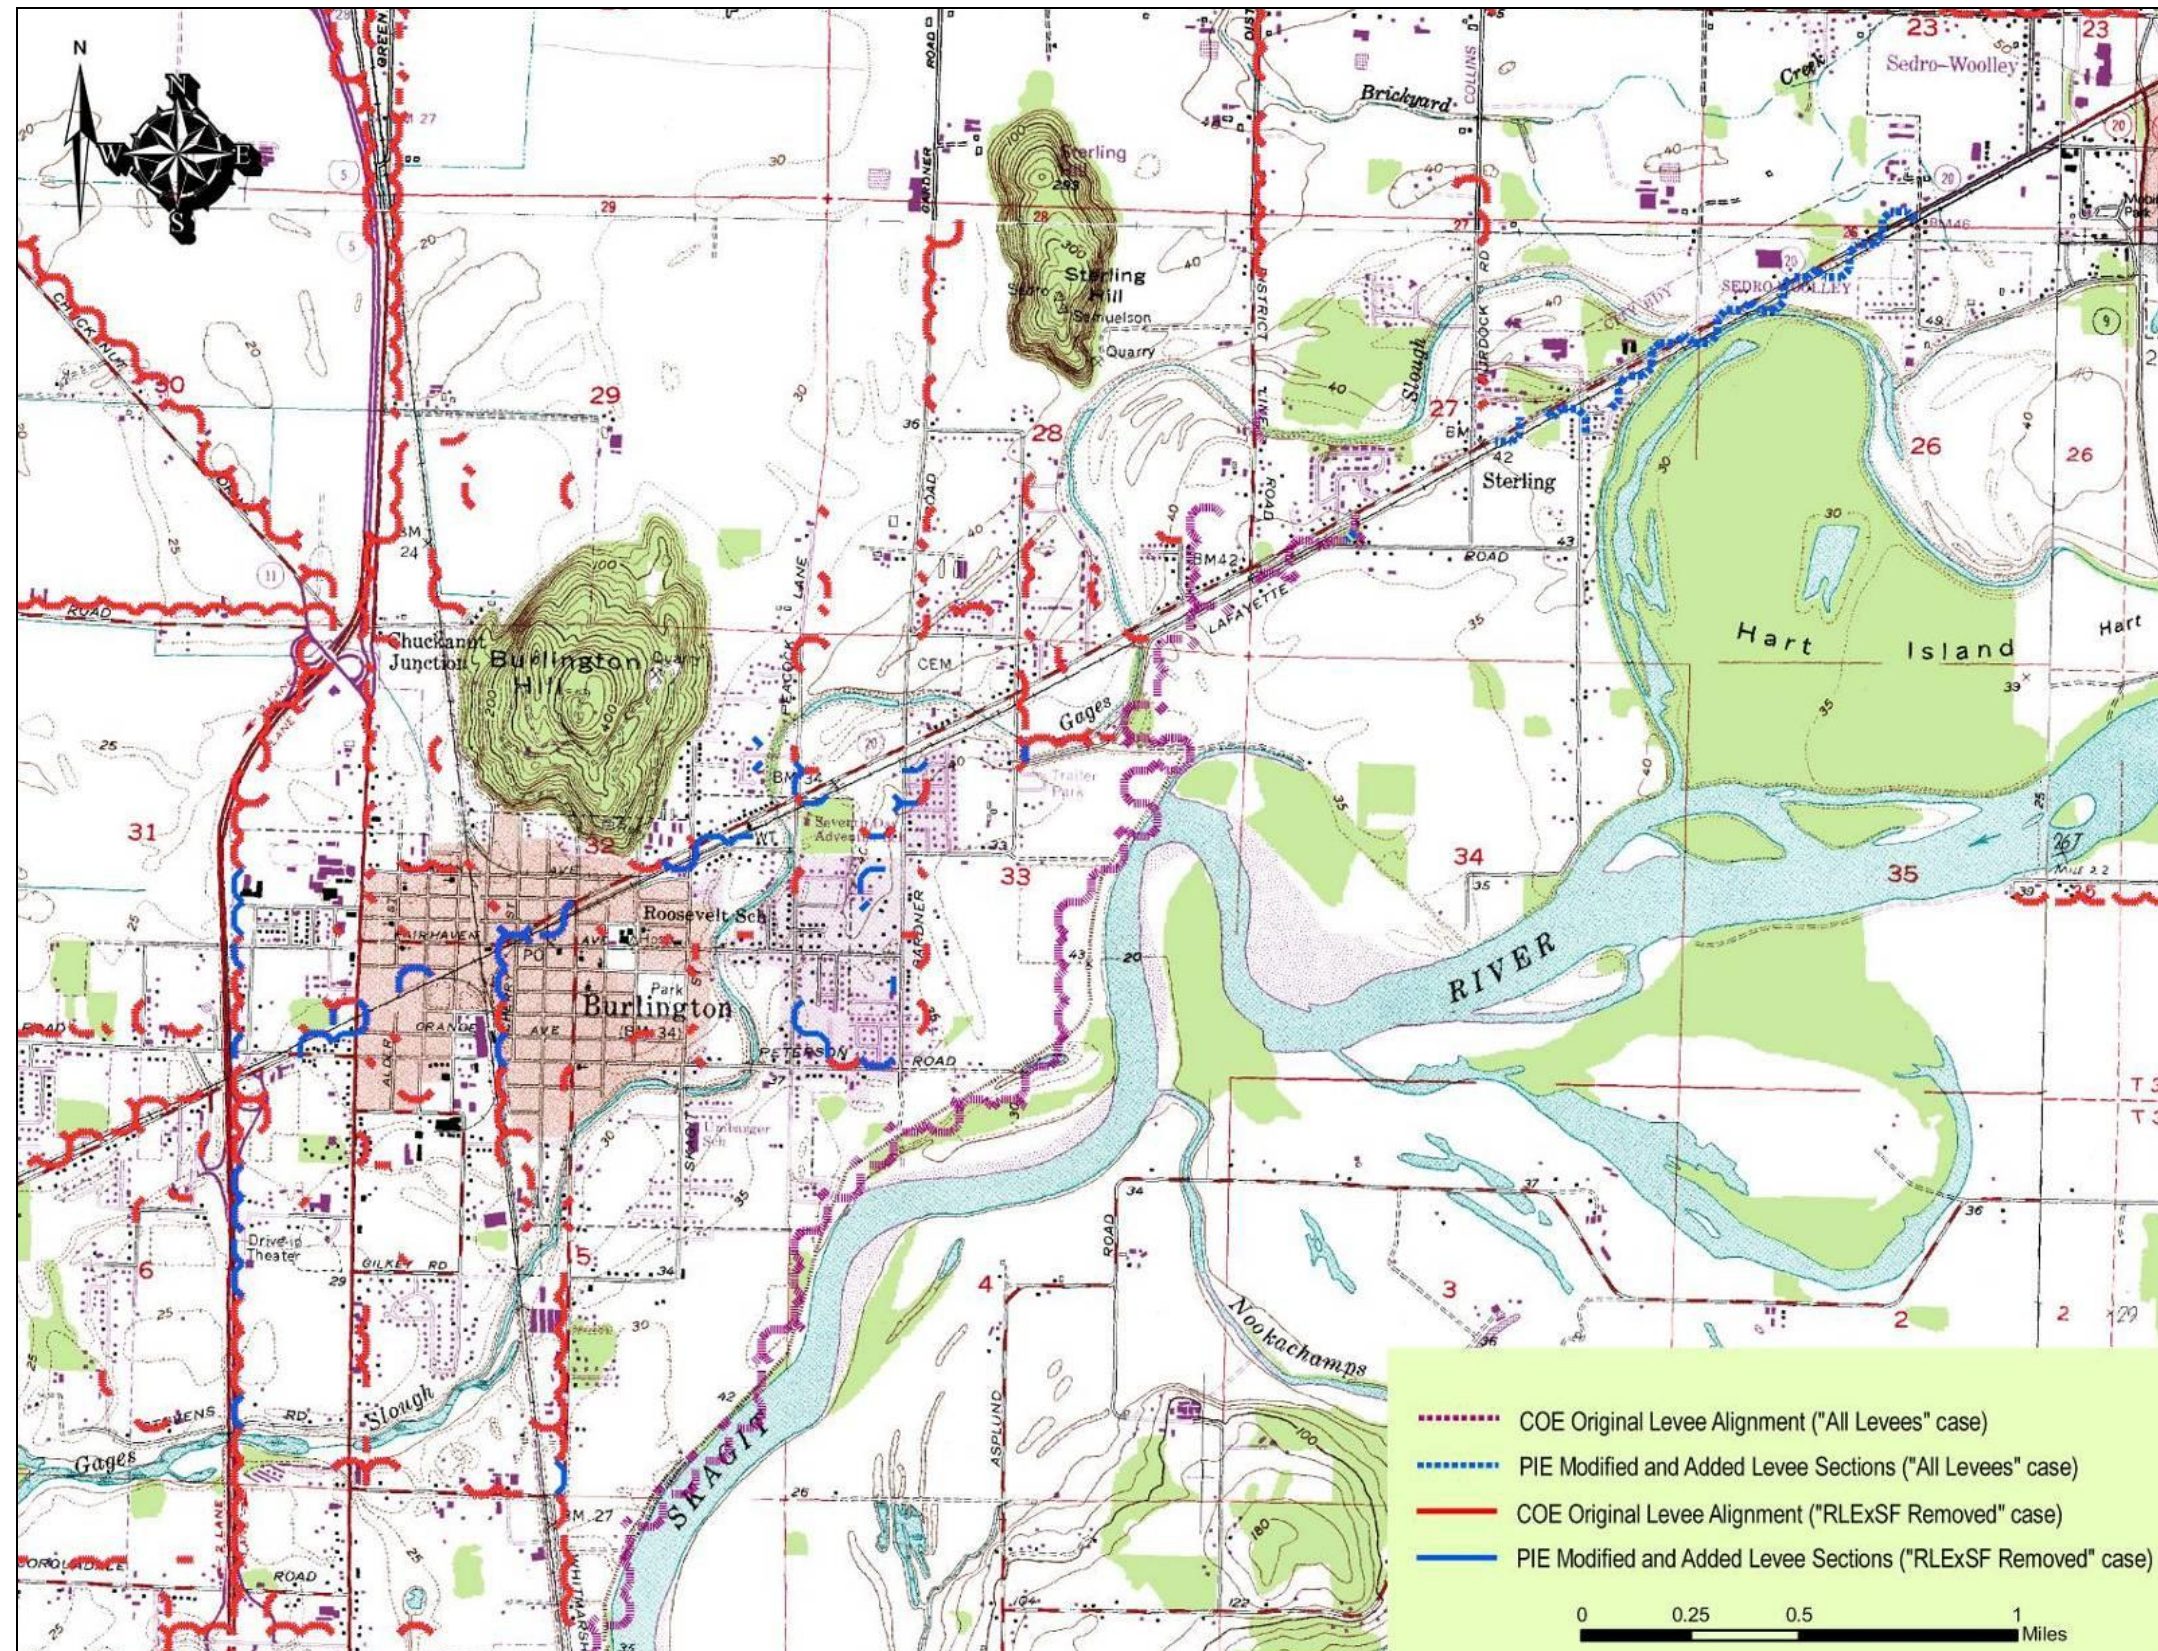
Figure 24. Comparison of COE Original and PIE Revised FLO-2D Model Levee Alignments

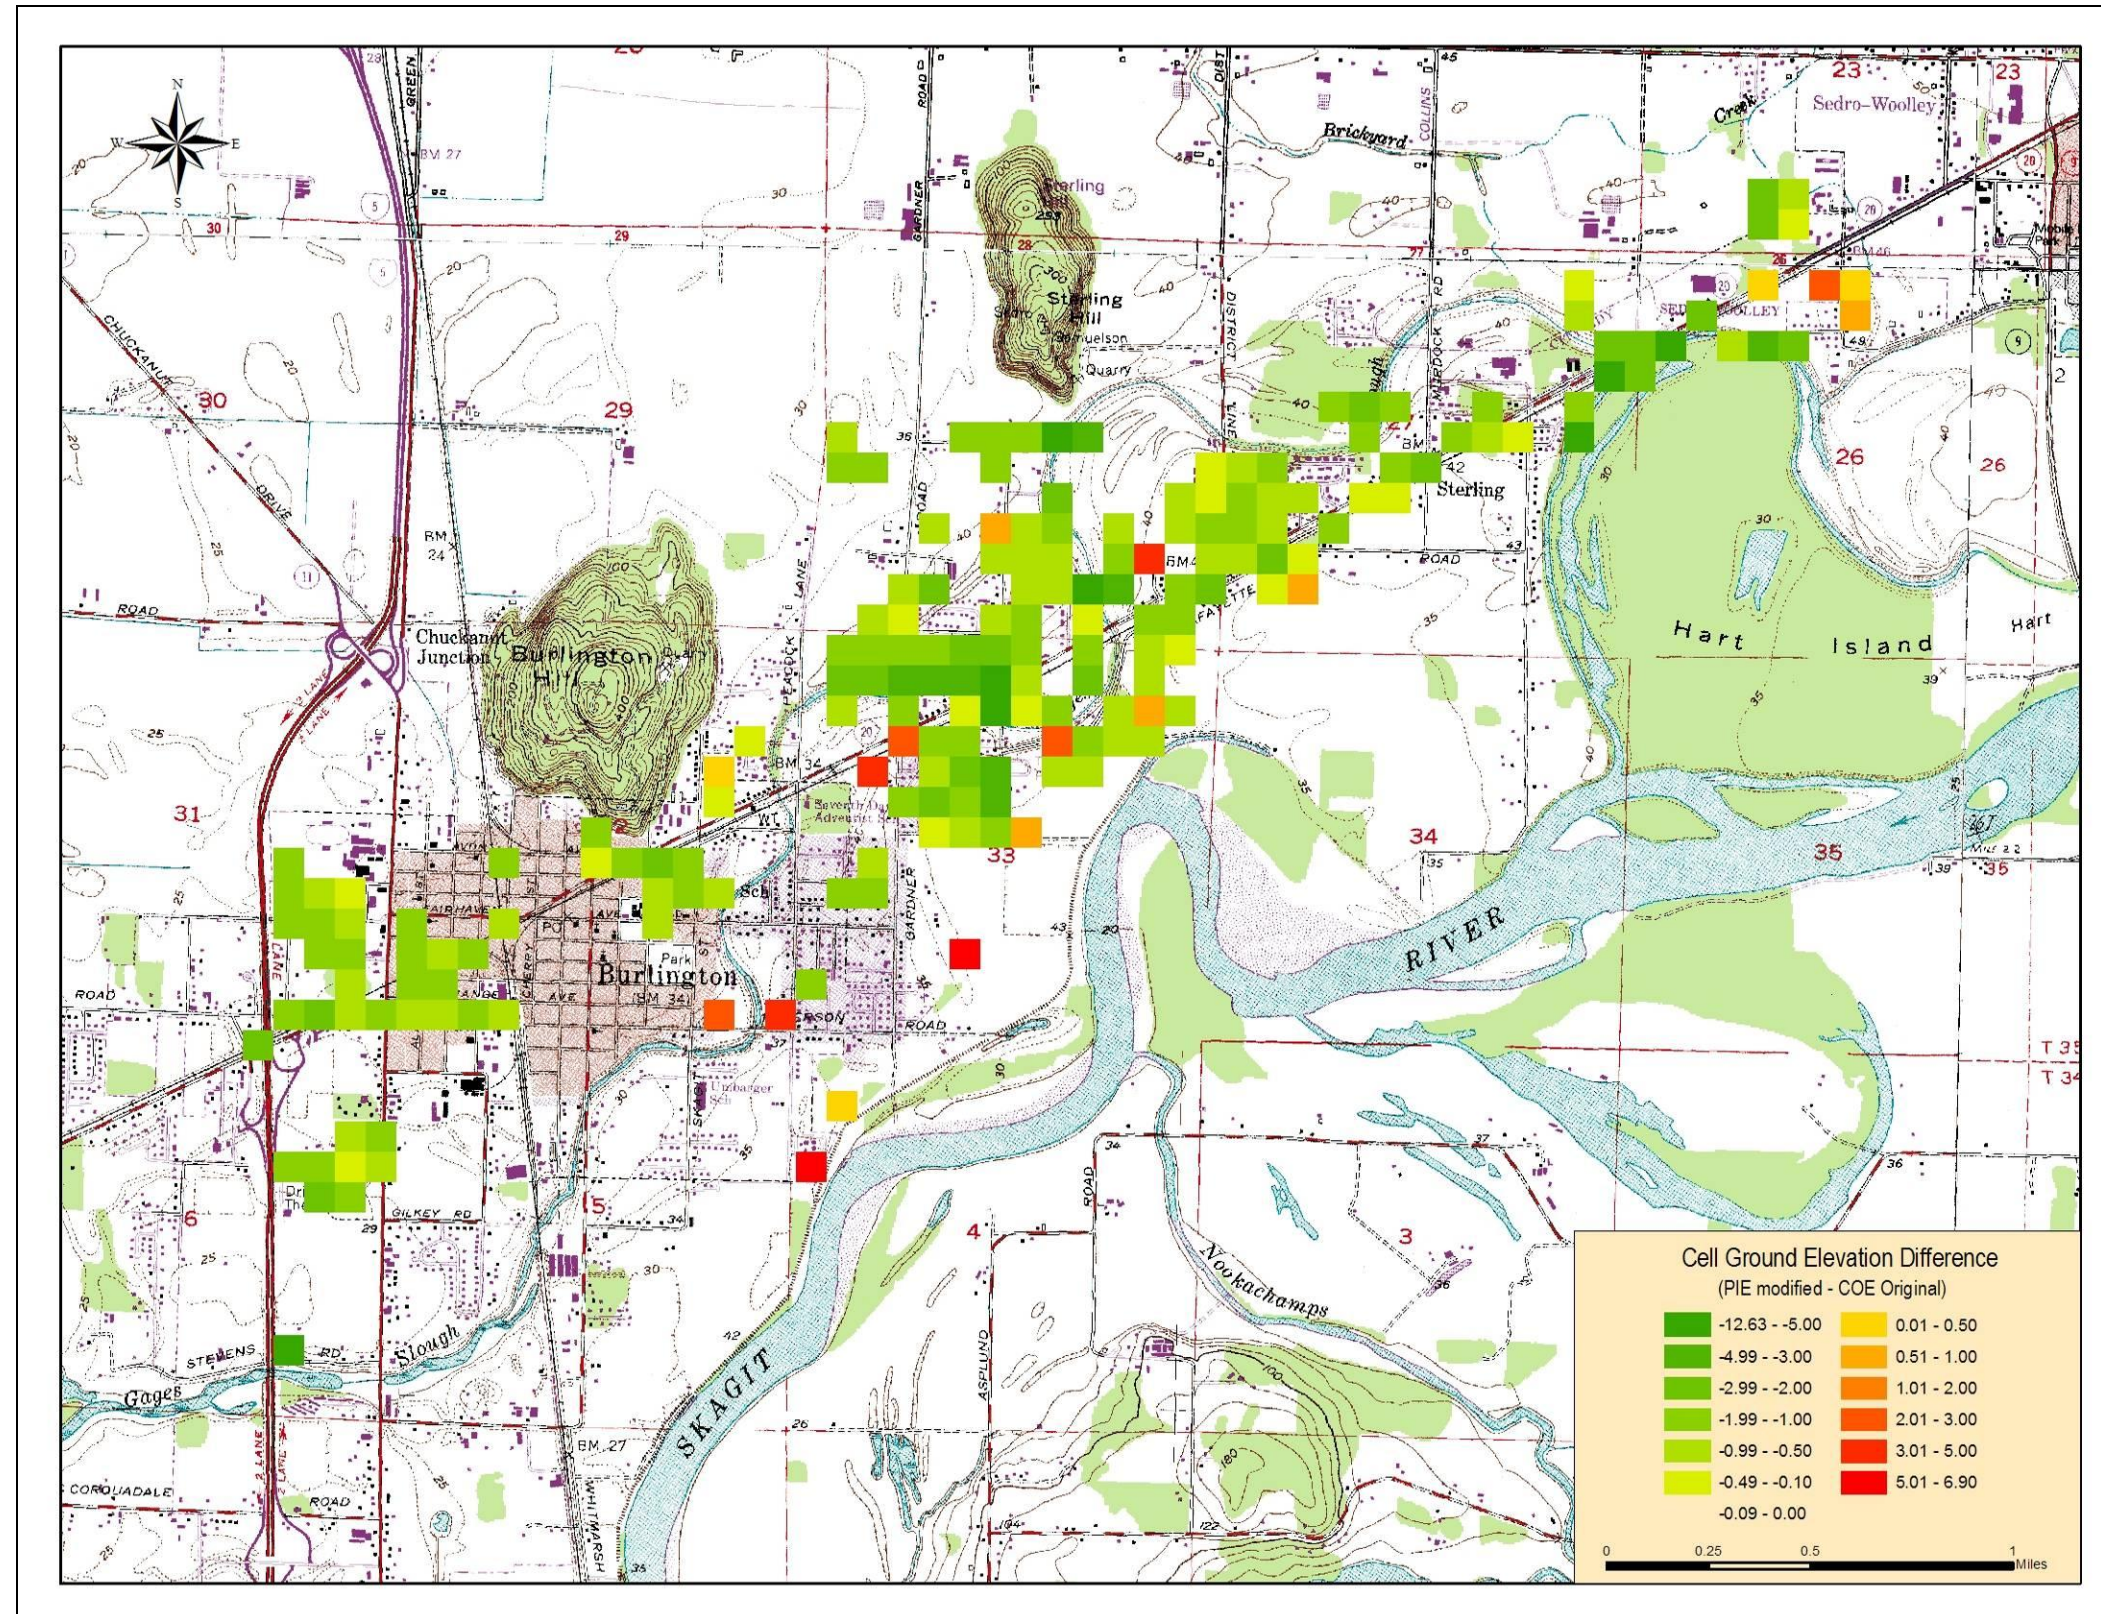
Figure 25. Cell Ground Elevation Difference between PIE Revised and COE Original FLO-2D Model
