## **Technical Report - Supporting Data and Analysis for Skagit River RFIS Appeal**

March 2011

**Skagit County, Washington**

Pacific International Engineering, PLLC

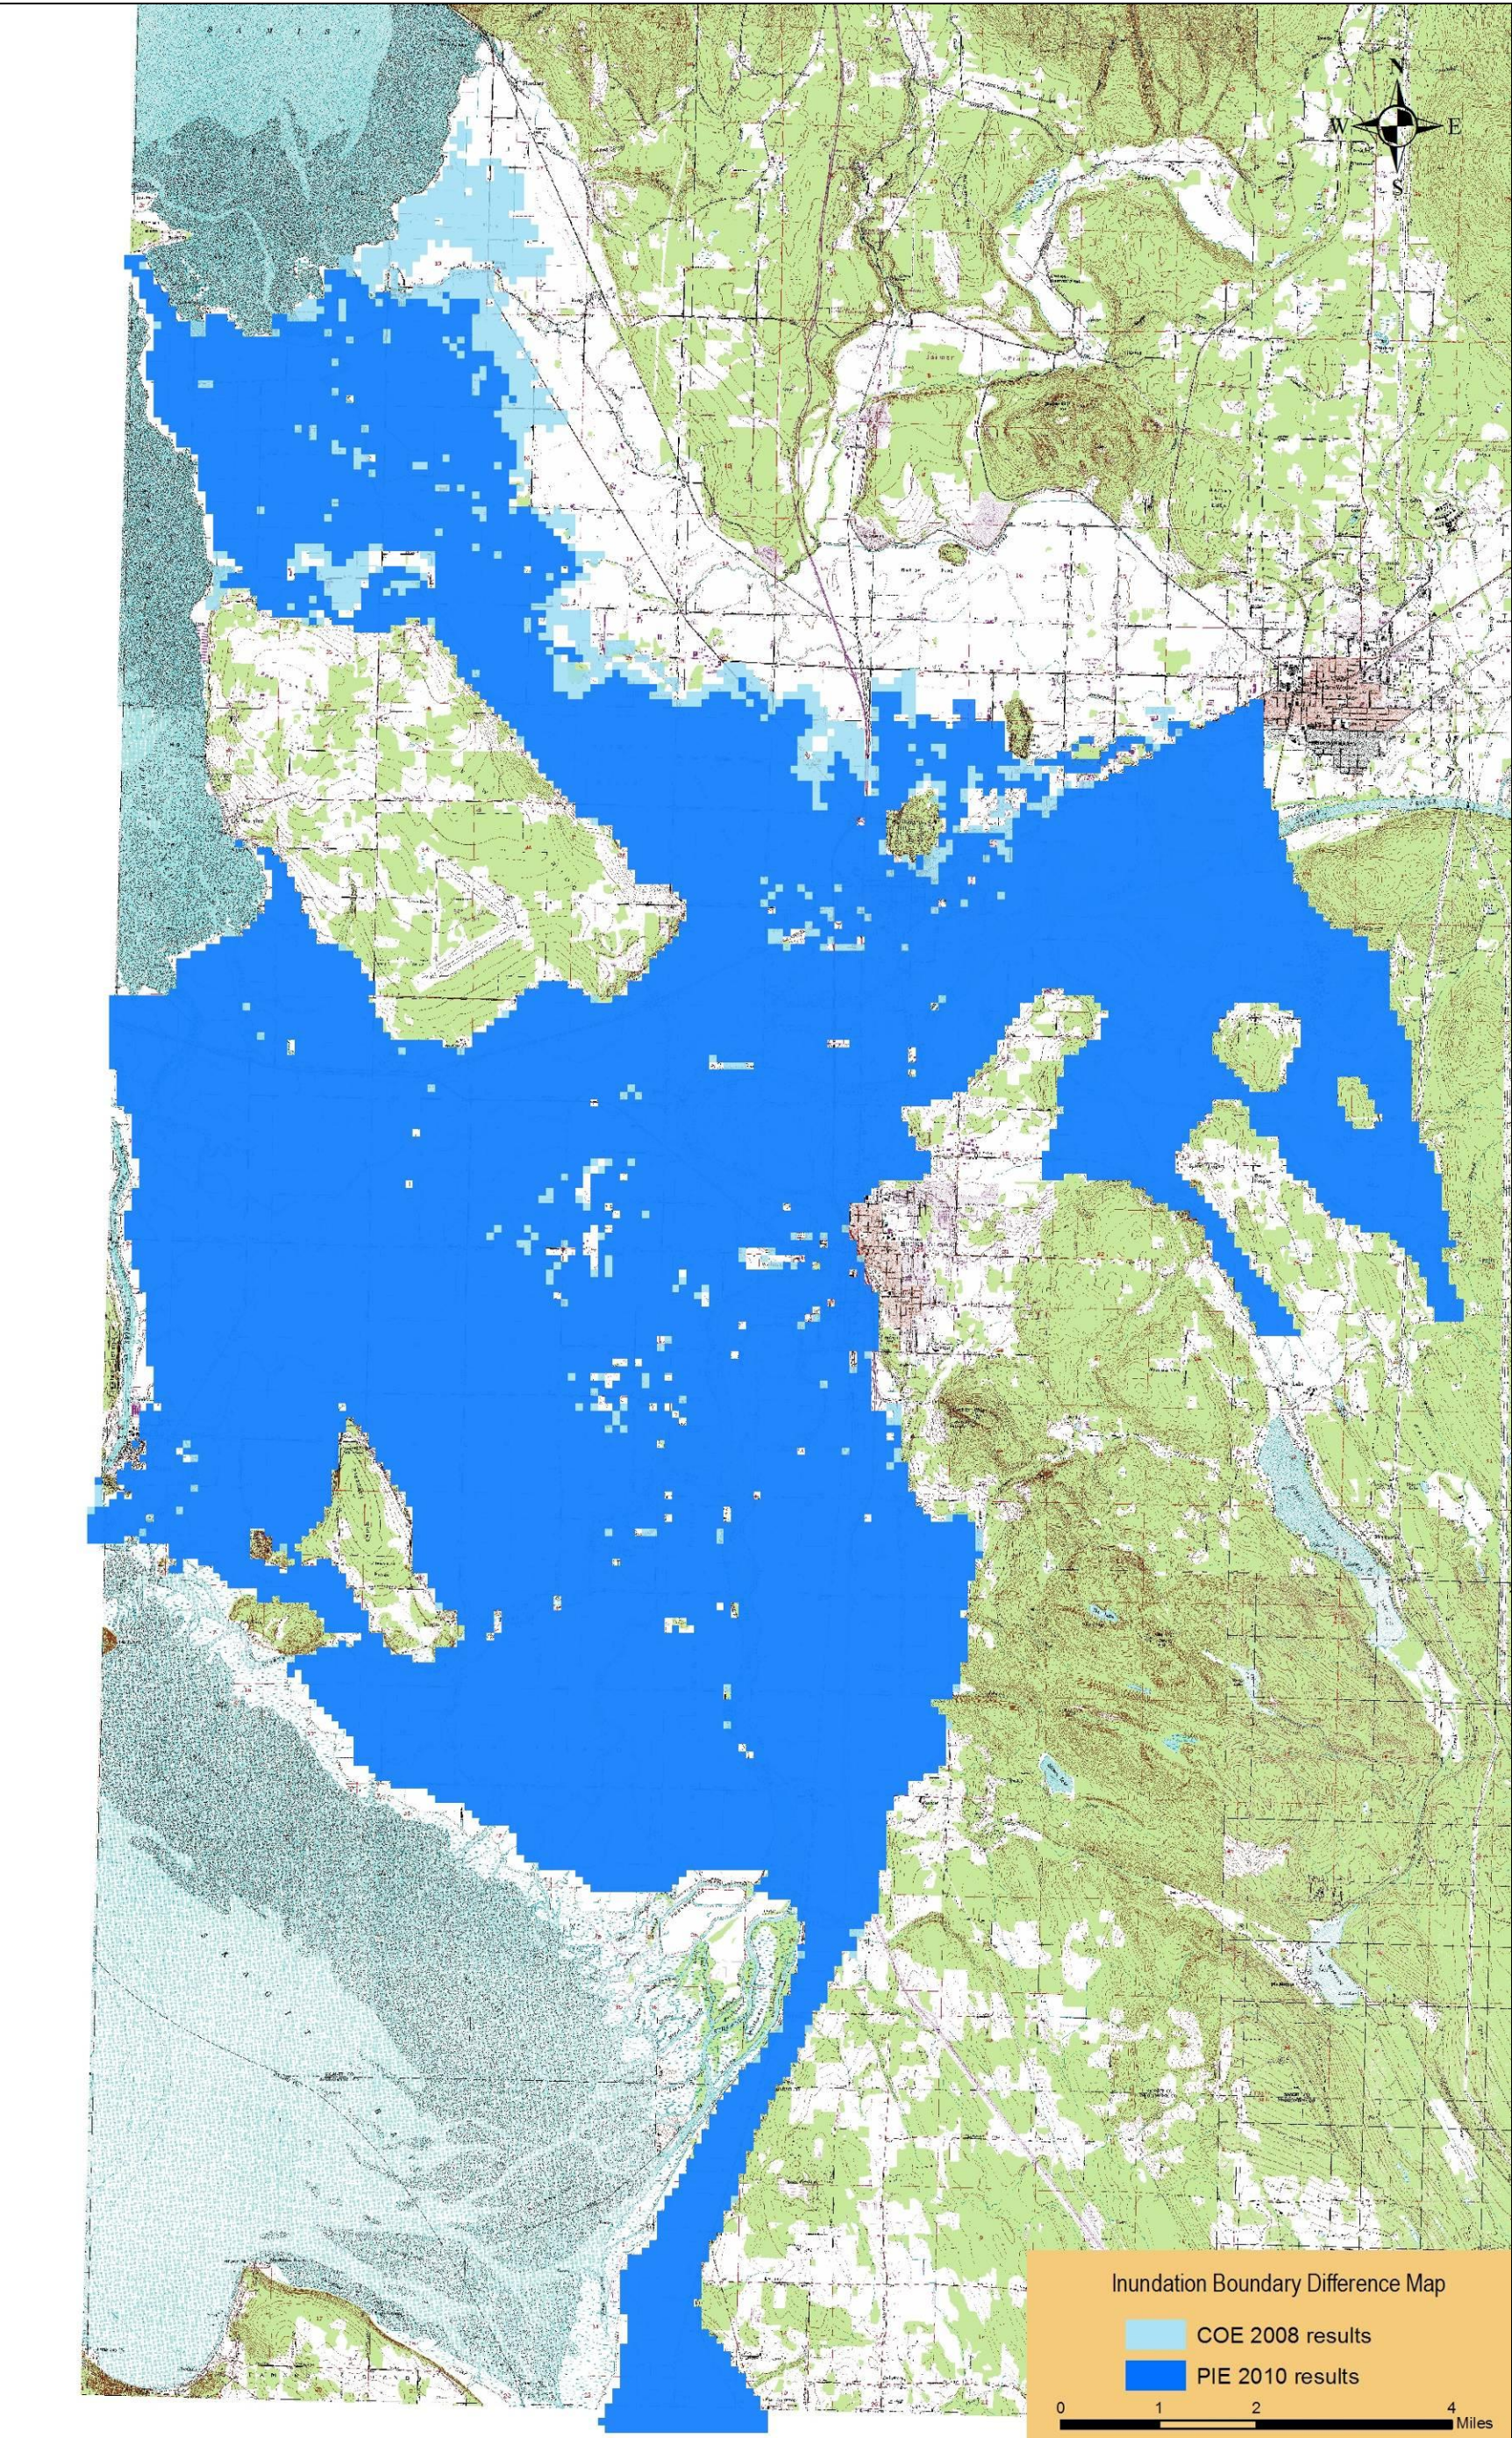
Figure 28. Base flood boundary difference map
